EvapTech, Inc

INSPECTION RECOMMENDATION LOCATOR:

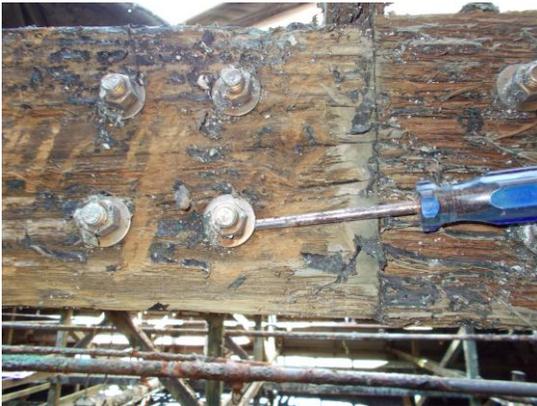
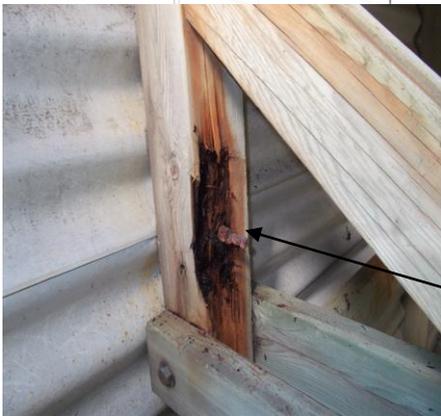
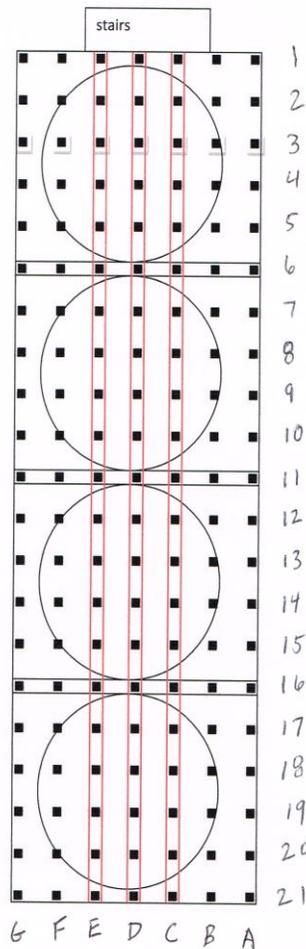
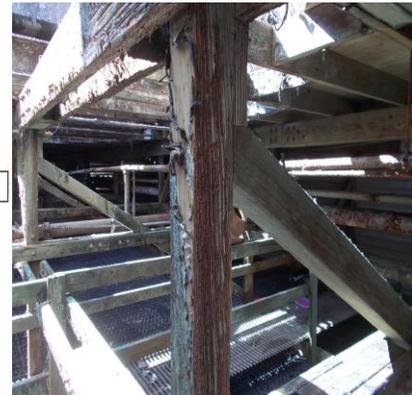
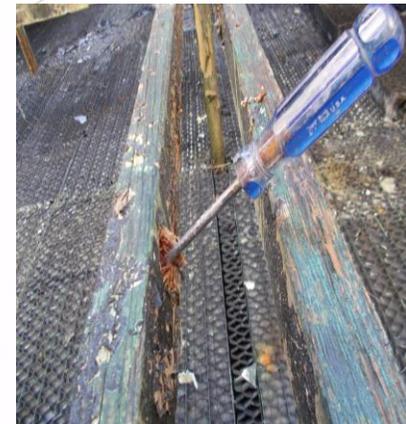
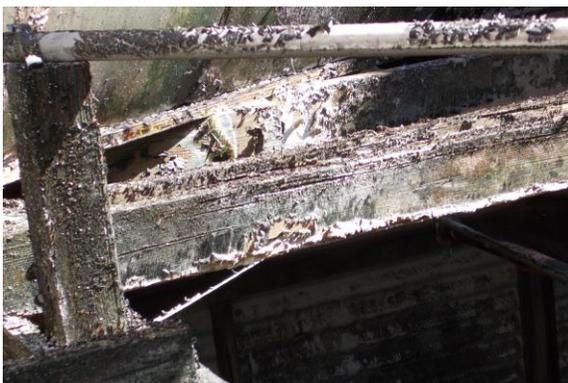
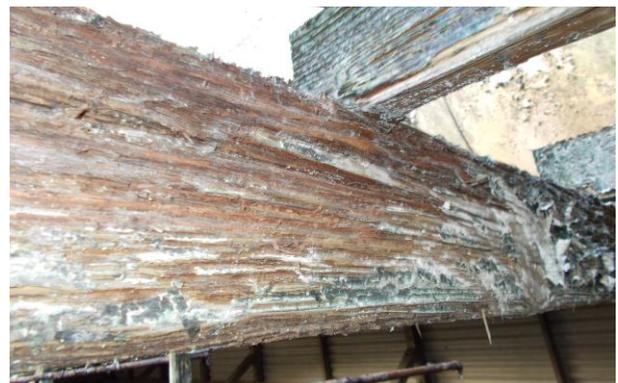
- All ties and/or girt lines under the fan area in the plenum area of the tower are in poor and failing condition. The three (3) double 2 x 8 girt lines at C, D and E (in the longitudinal direction – SEE SKETCH BELOW) should be replaced from one end of the tower to the other. All the 2 x 6's at the fan deck level, above the 2 x 8's in the transverse direction, under the fan area, should be replaced as well. Plenum structure area above the drifts, exposed to direct sunlight, is a major concern for wood deteriorating - areas should be replaced.

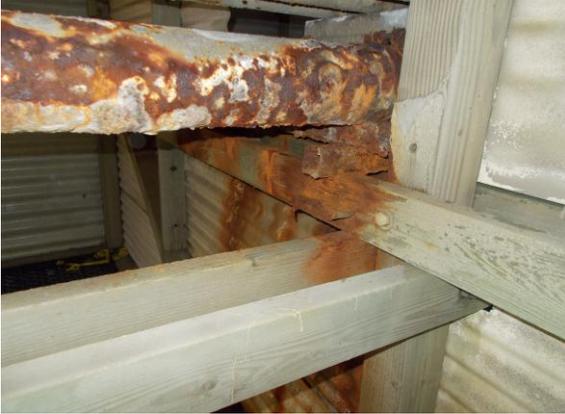
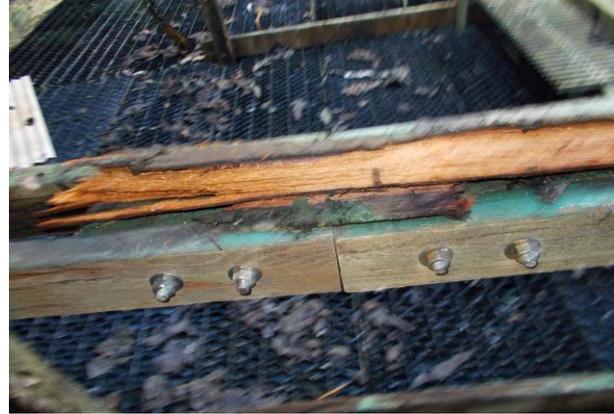
- In addition to deteriorating members in the plenum area under the fans, there is sufficient evidence of iron rot from old sprinkler hanger hardware on many of the 2 x 8, 4 x 4, and 2 x 6.

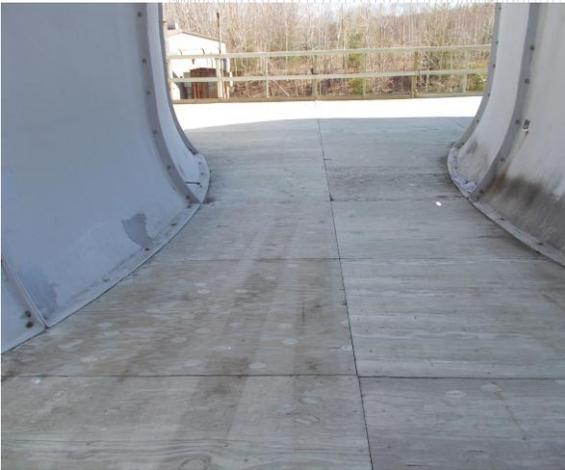
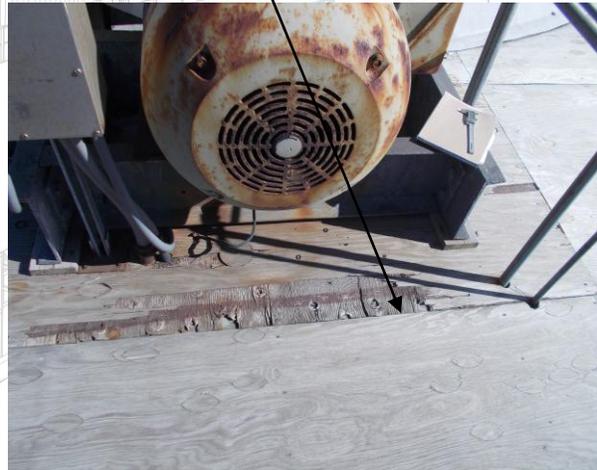
- The fan deck is not the original deck. None of the seams are staggered. Plywood under the mechanical support – **motor side has not been replaced.**

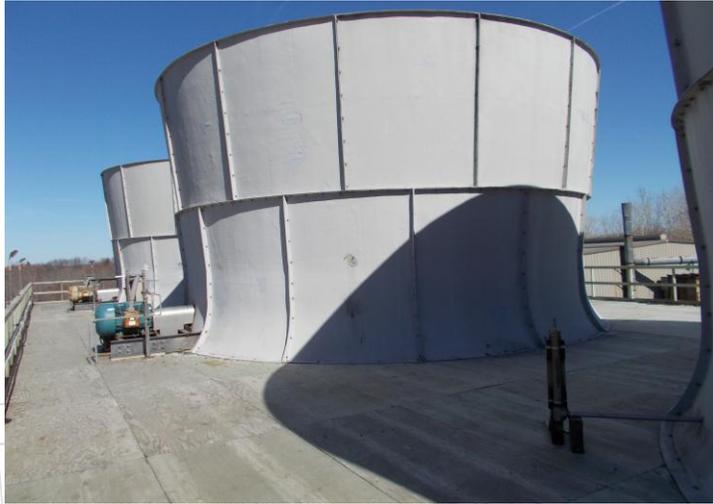
- 28' diameter – 18' tall stacks are in good shape. Hardware should be checked occasionally for tightness – several locations @ loose hardware were found.

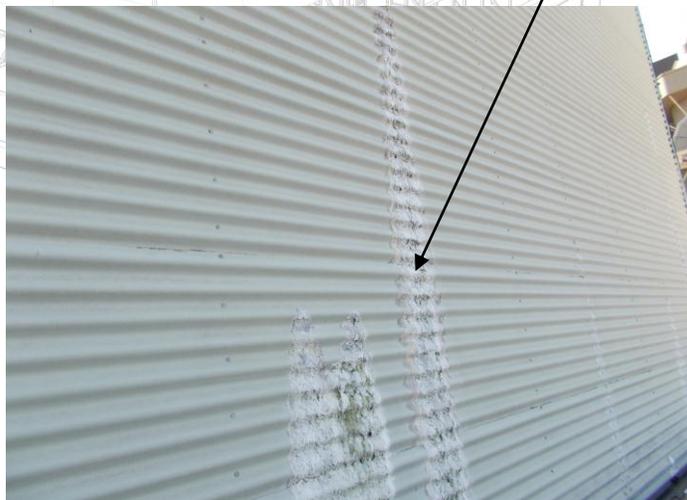
- Casing is in fair condition. Areas throughout where exterior gel-coat is worn off exposing fibers throughout. Some leaks are evident, especially at bolt connections on the end walls.

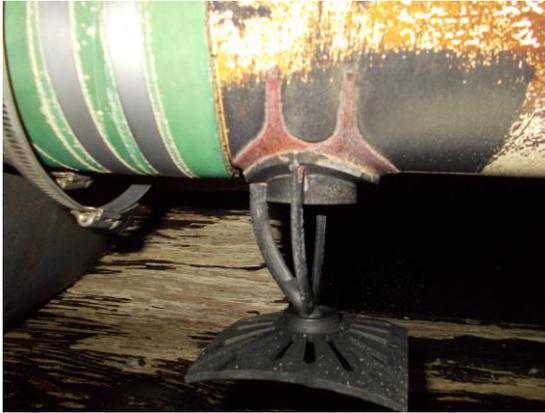
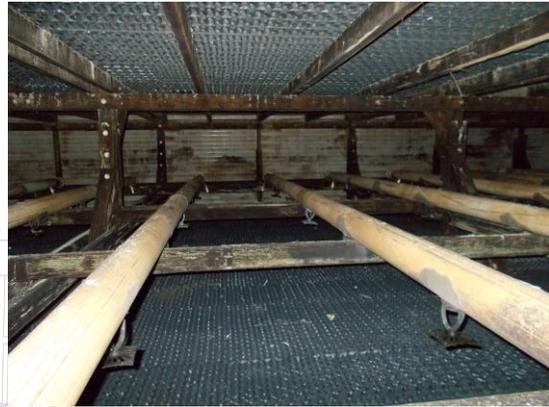
- The distribution system is in good condition. There are no issues with the fiberglass main header or the 4" PVC lateral spray arms. Nozzles are snap-in style – some are glued and some are held in with tie wraps or radiator clamps. There are about 4 – 6 nozzle with broken splashplates in each cell. Evidence of not a complete radial water pattern has been noticed on the top of the fill. Monitoring of the system is recommended.

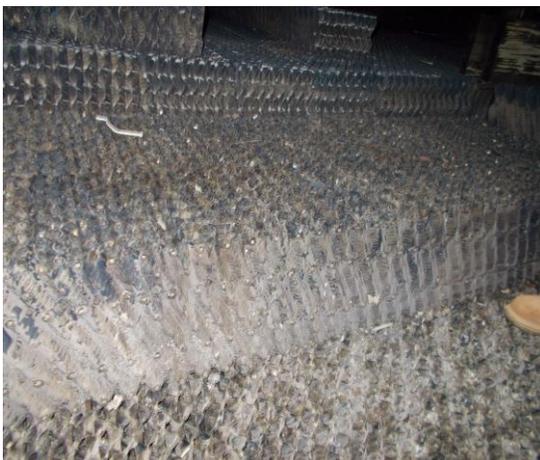
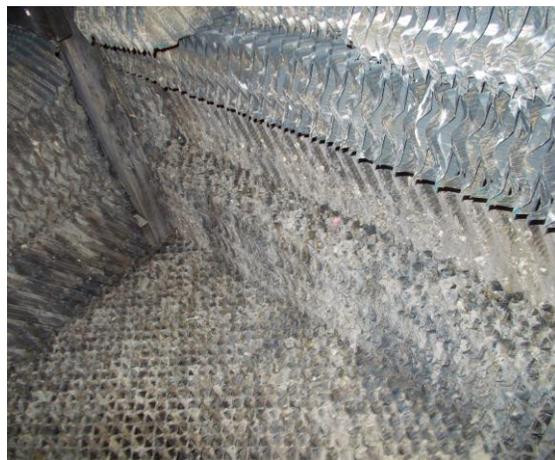
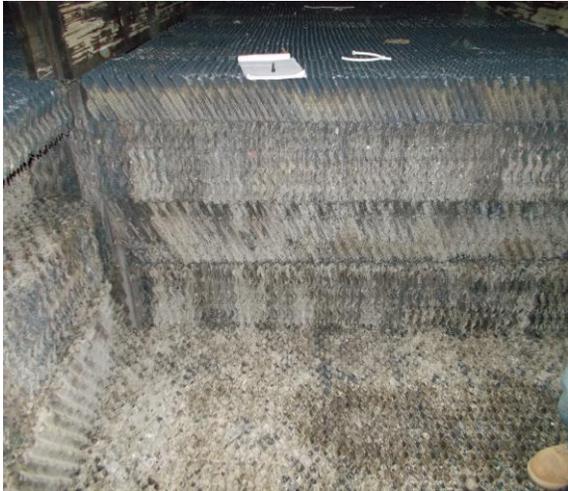
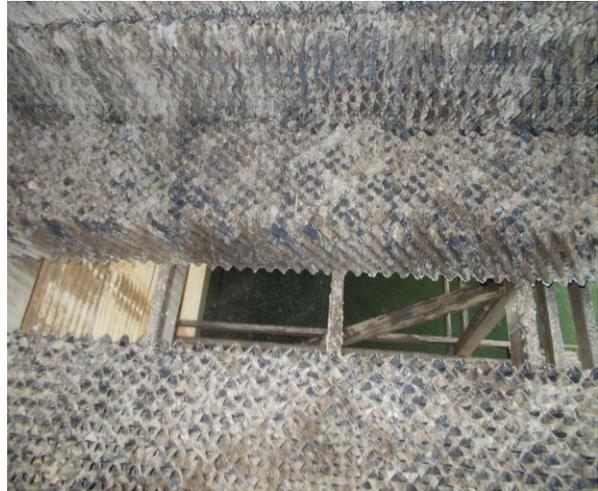
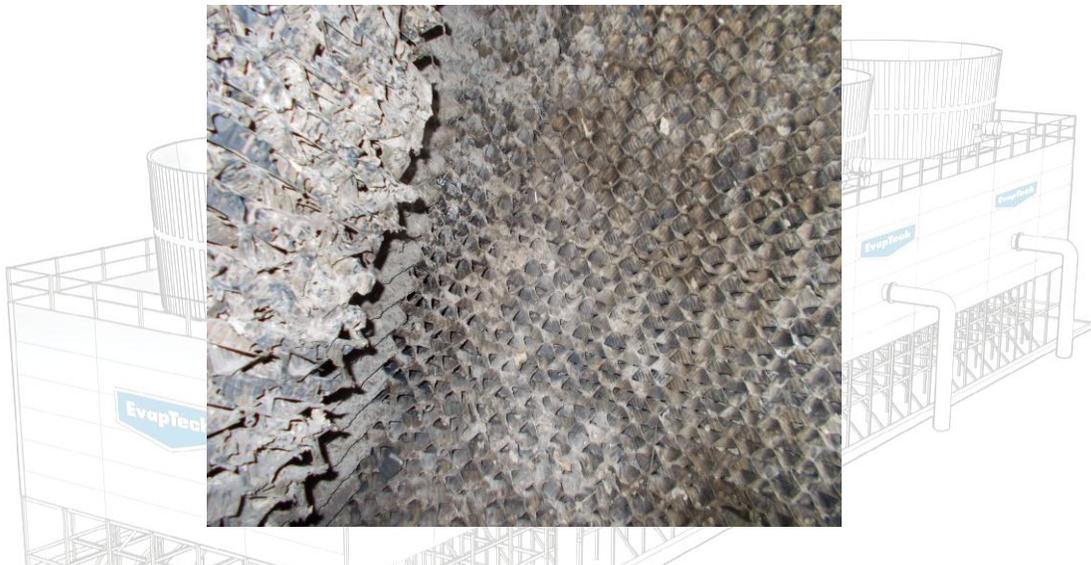
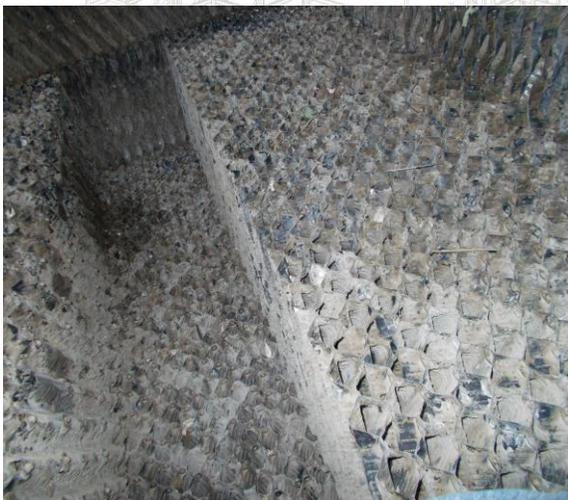
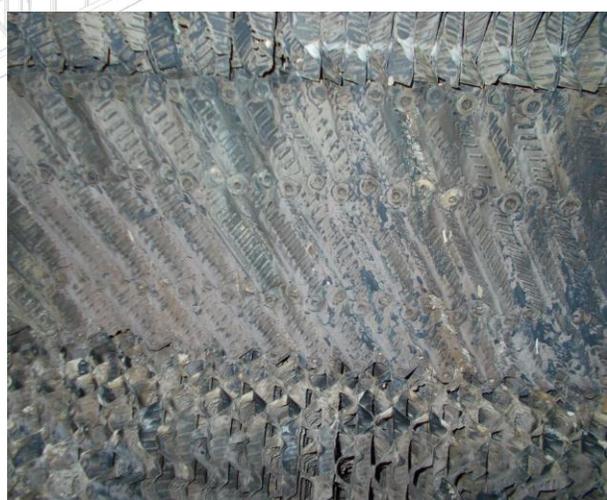
- A main focus of the inspection is to value the condition of the fill tiers, removing packs from various layers and notice any clogging or fouling that may have occurred. The cells maintain 4½ tiers of fill media, 4 tiers of 1' depth and the top tier ½' depth. As a reference, a typical module of 1' x 1' x 8' will weigh approximately 24 lbs. Packs removed (from top to bottom) from Cell 3 & 4 are as follows:
 - Tier 1 (top) 6" pack – good condition = 12 lbs.
 - Tier 2 – 1' pack – slight plugging, heavy solids forming = 30 lbs.
 - Tier 3 – 1' pack – plugging, heavy solids = 33 lbs.
 - Tier 4 – 1' pack – 20% of module plugging, heavy solids = 39 lbs.
 - Tier 5 – 1' pack – flutes restricted, serious plugging = 70 lbs.

- Fill media should look to be replaced with high efficiency vertically fluted media – EvapTech TechClean (Optimal Balance Between Thermal Performance and Clogging Resistance) – will validate after base line performance test in July 2012.

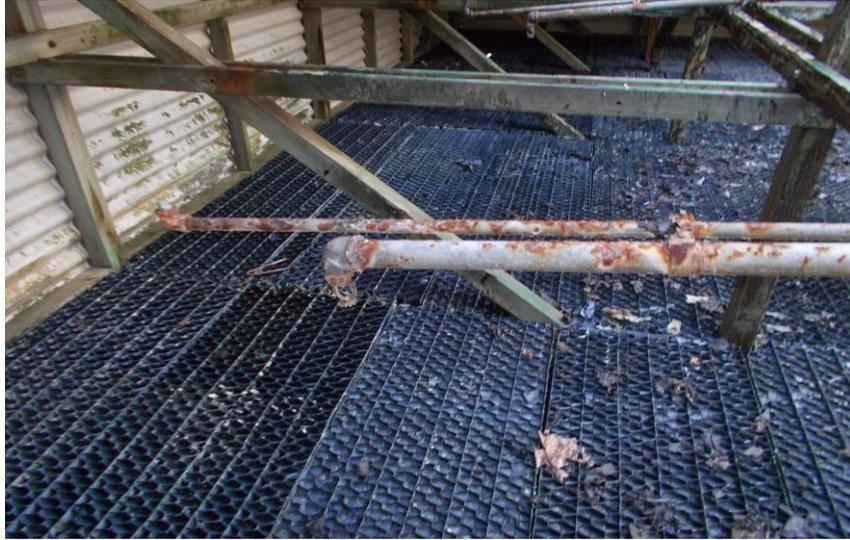
- The PVC drift eliminators are in fair condition. A few areas were noticed where there are gaps and/or broken modules. Estimated that there are about 12 modules per cell (1' x 8') to be replaced.

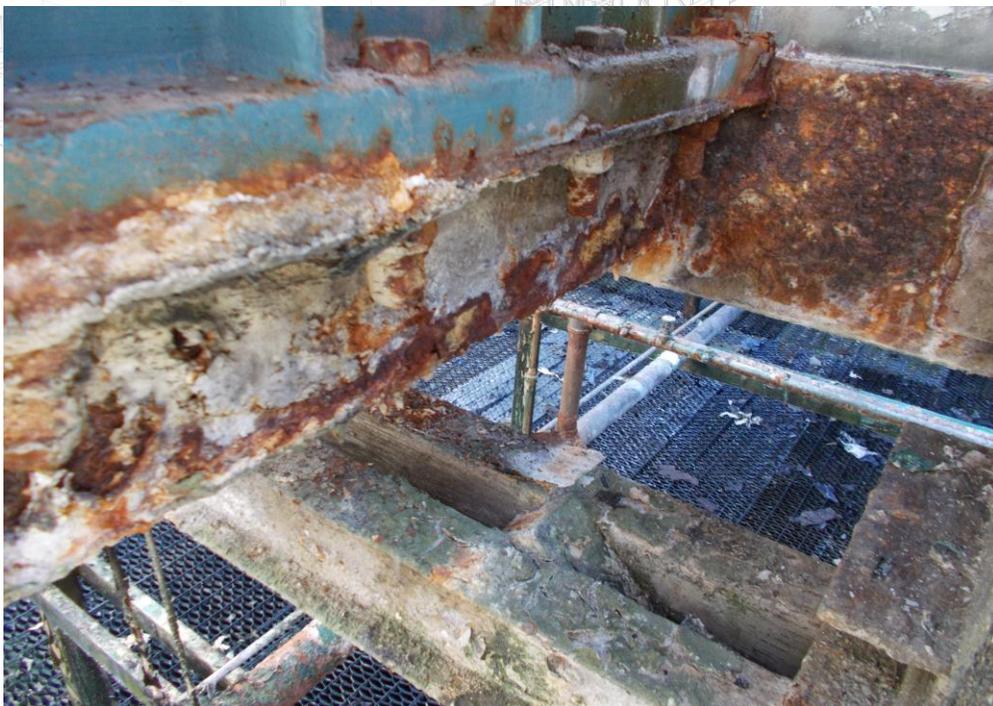
- Mechanical equipment supports are in very poor condition in all cells; Cells 1 & 2 is in the worst condition. Major scaling, rusting and scaling of the steel are evident directly under the fan and gear reducer.

- 2 x 6 @ A/B 20, A/B 19, A/B 18, and A/B 17
 - 2 x 4 @ CDE 17, CDE18, CDE 19, CDE 20, C 17/18, D 17/18, and E 17/18
-
- Replacement of mechanical equipment frames.

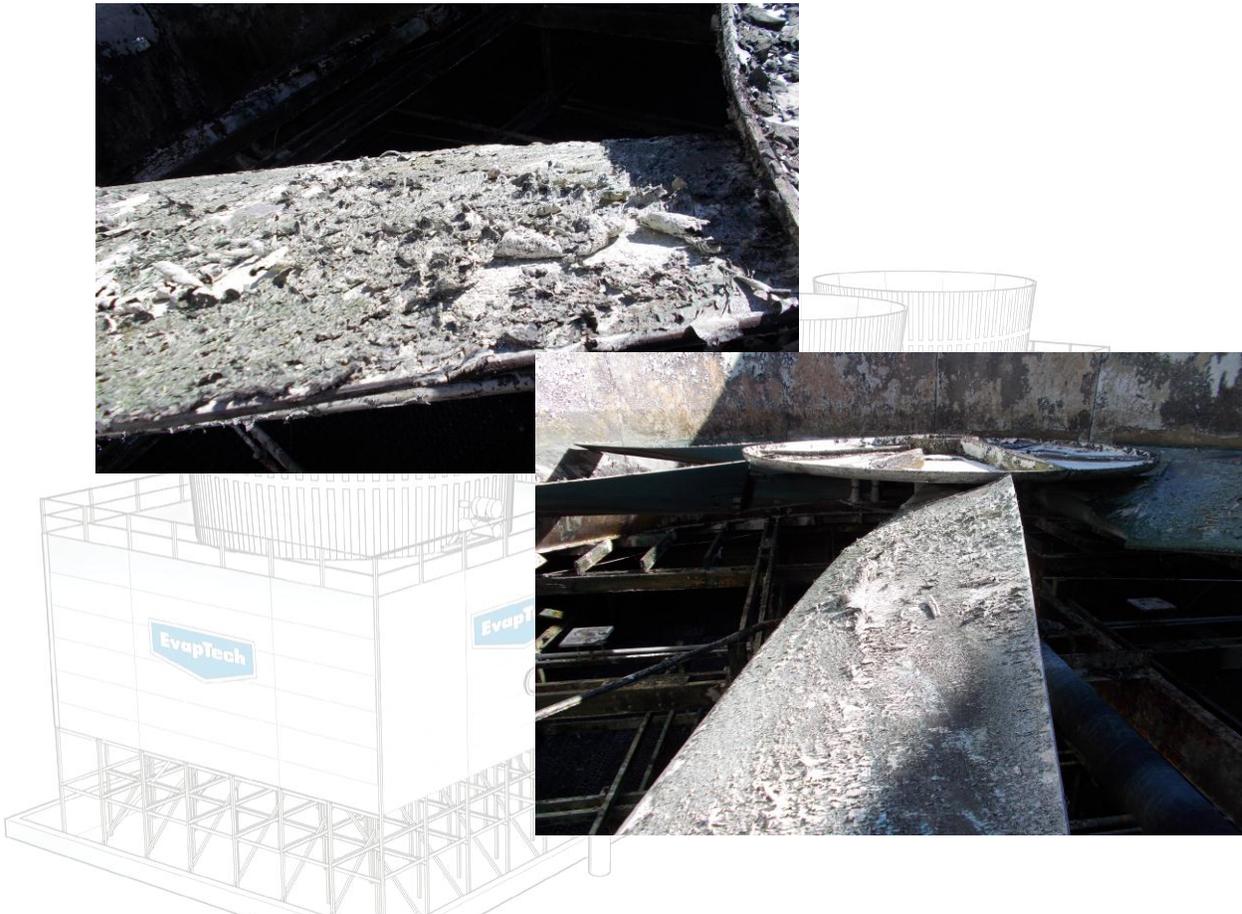
- Fan assemblies are in fair condition. A major problem is that there is a fair amount of scaling and solids adhering to the individual blades. The amounts realized would cause the fans out of balance due to weight, and create vibration; customer has verified that the fans do shake quite a bit. Recommend cleaning blade solids, re-balancing when completed. The fan blade hardware is in poor condition and should be highly monitored for replacement.

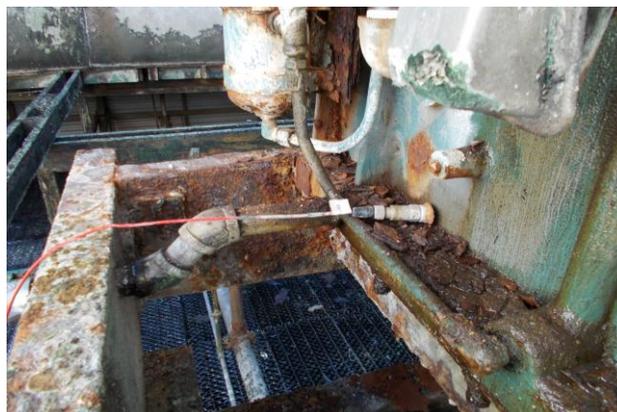
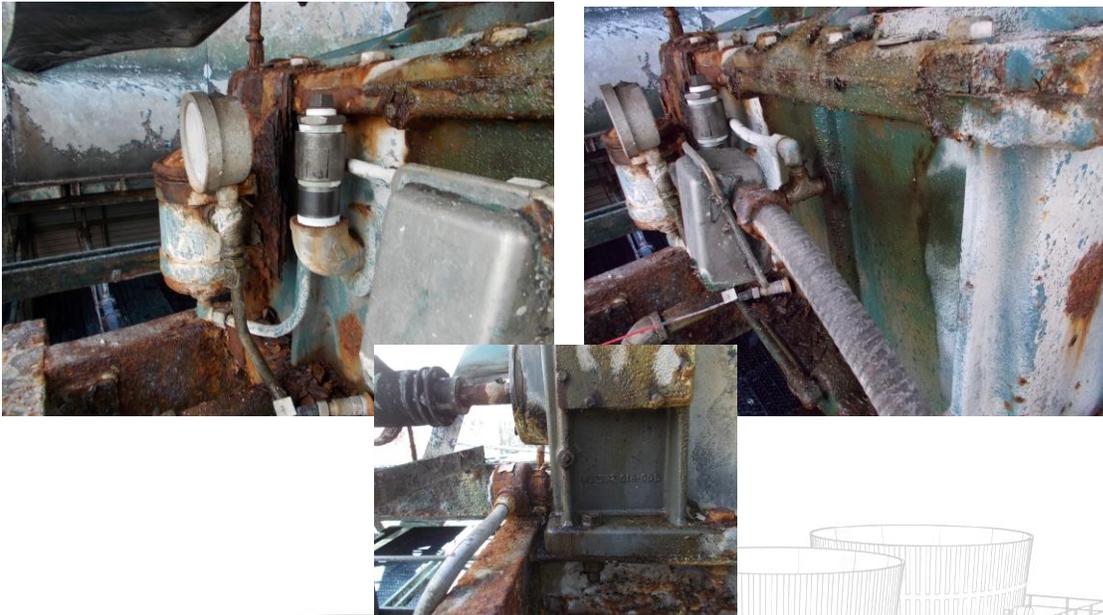
- Gear reducers are in fair condition, however all attachments, such as probes, heaters, fittings, etc. are in poor condition; rusted badly. All cells show evidence of leaks from the pinion seals and upper gaskets in the gear casings. Cleaning and painting the casing is recommended, along with gaskets seals, filter assemblies and heaters. NOTE: the lash and bearing play are good in all 4 gears, with a little more gear lash in Cell 4.

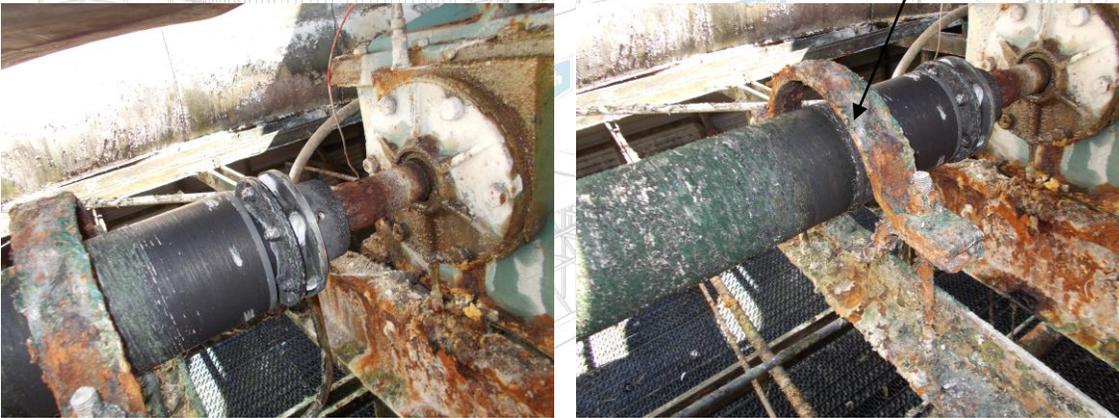
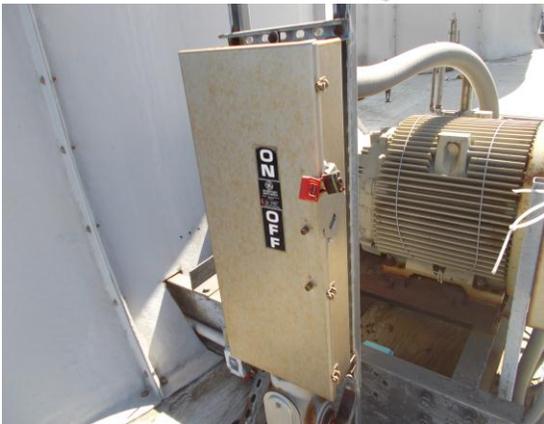
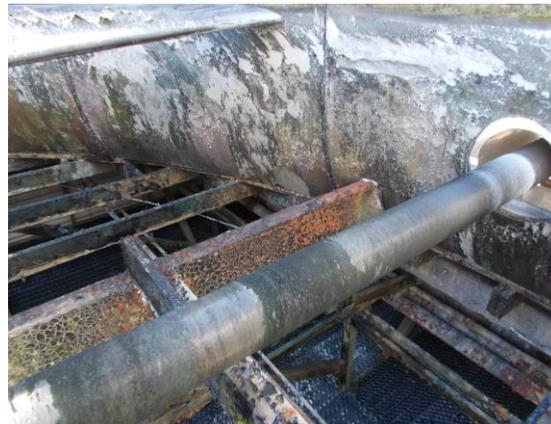
- Motors and drive shafts are in good operable condition. Drive shafts had some solid build-up and should be routinely cleaned. Shaft guards are rusted and should be replaced.

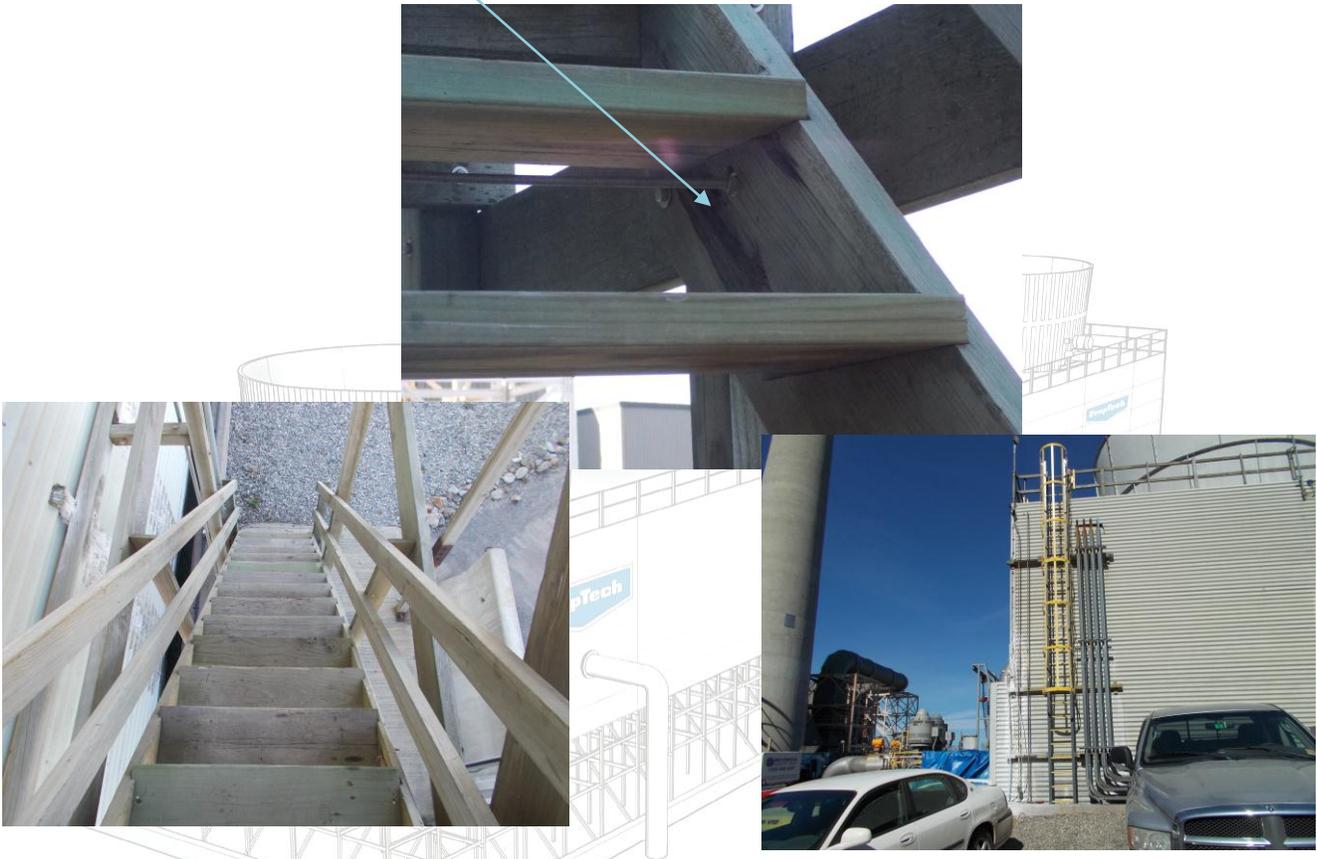
- The original ladder was replaced with fiberglass – good condition. Stair tower treads are showing wear. One of the stringers on the stair does have a fairly large crack – should be addressed immediately for safety reasons. So movement in the stair towers – additional bracing should be investigated.

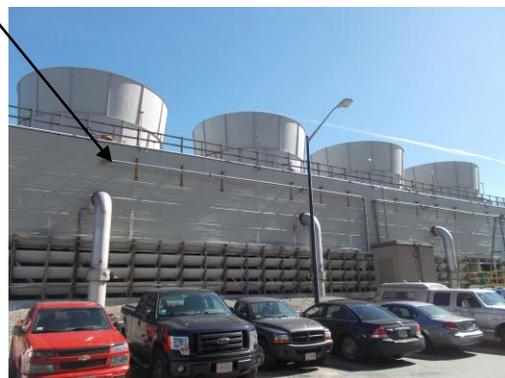
- The fire protection system is fed by a 6" water line pipe attached to the longitudinal face of the cooling tower. The pipe was attached with uni-strut and bolted through the columns along the casing wall. The original bolts have rusted substantially and pipe supports within are in danger of falling. The rusting of the bolts has created a considerable amount of iron rot in the structural columns as well as handrail posts creating safety concerns.

- Fire protection system – revalidate existing system or look to install new piping.
 - Maintenance on the gear reducers.
-
- As Follows:
 - Typical Inspection & Maintenance Calendar

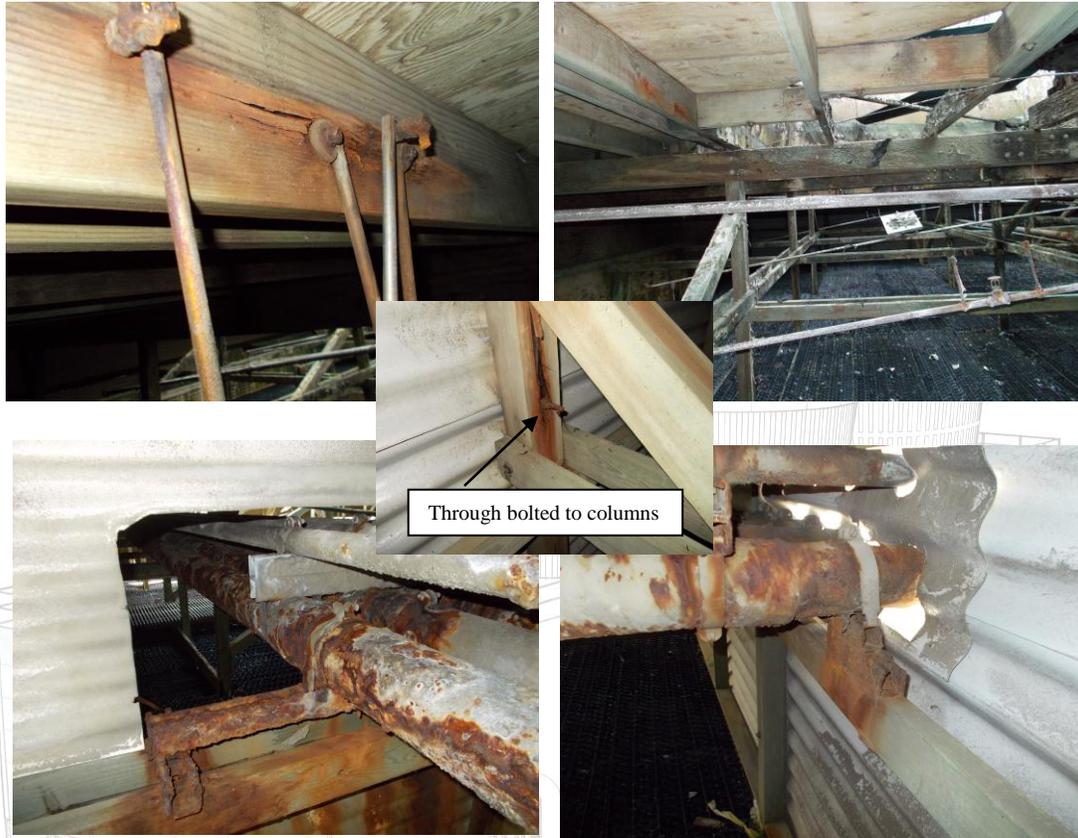
Additionally there are a number of pipe hangers that have fallen and are showing significant corrosion. Stainless steel fasteners should be considered. Note of smaller lines on the system are inactive – they should be removed.
