## Sample Inspection Report

Tower Reference Number: **00000A01**

2-cell FRP-structure counterflow cooling tower, each cell measuring approximately 30' long × 30' wide × 24' tall with a 22' diameter fan.

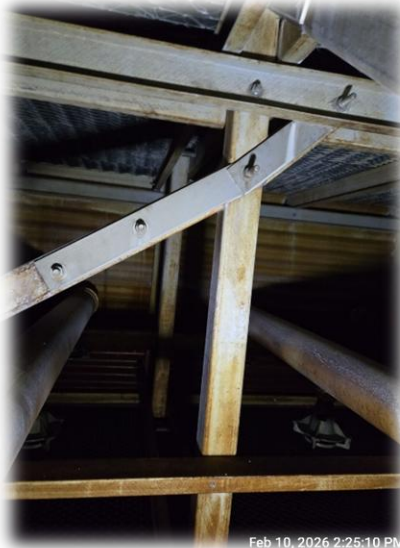
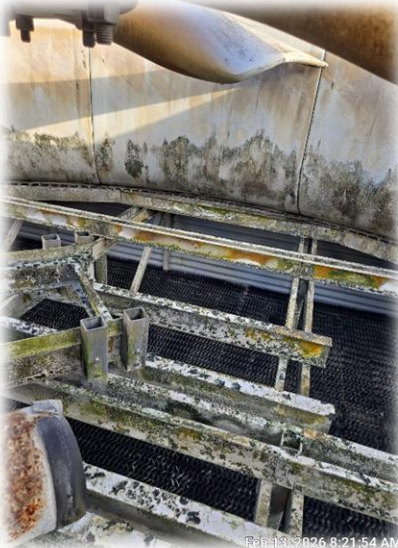
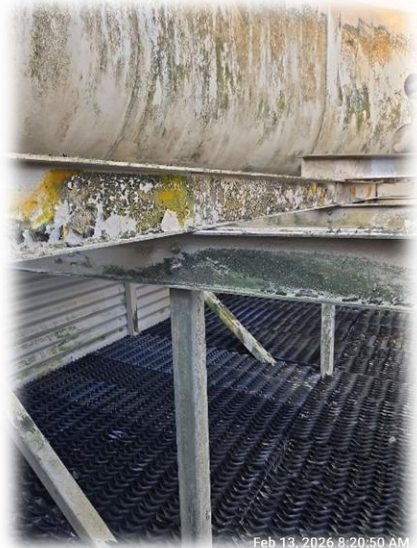
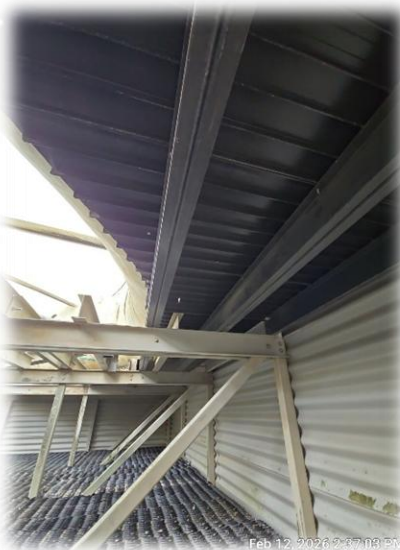
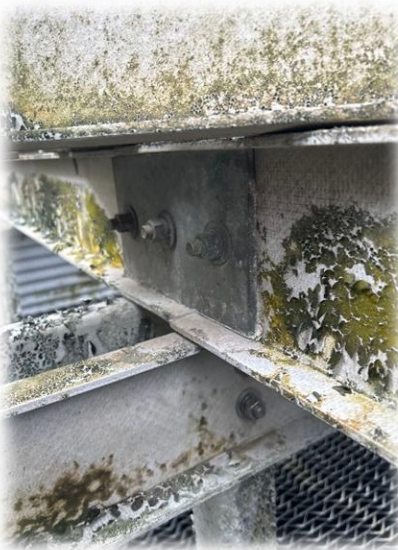
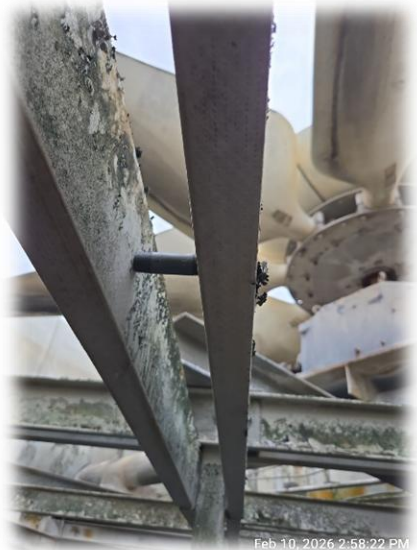
Acceptable

The structure is in fair condition with no loose or missing hardware found during the inspection. Although no damaged members were noted during the inspection, minor weathering was noted throughout the tower that should be monitored during future inspections.

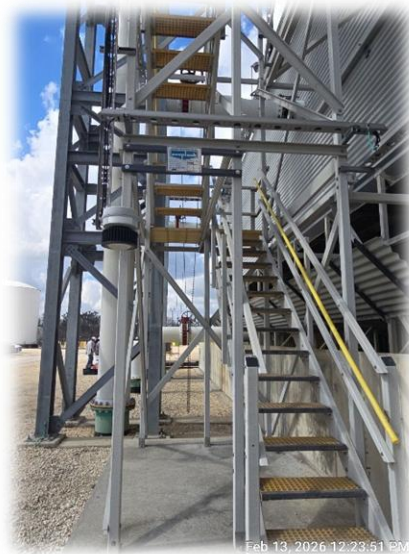
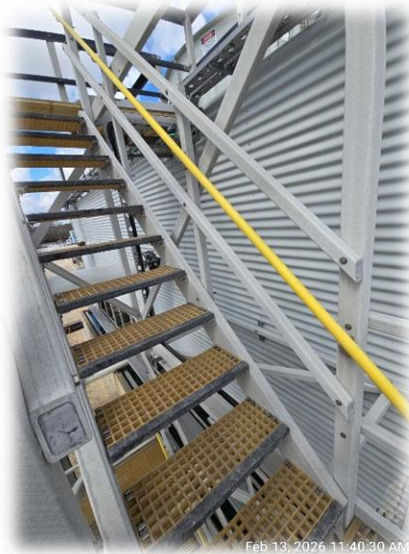
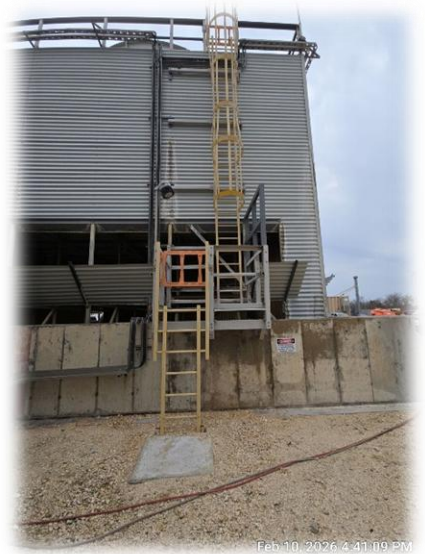
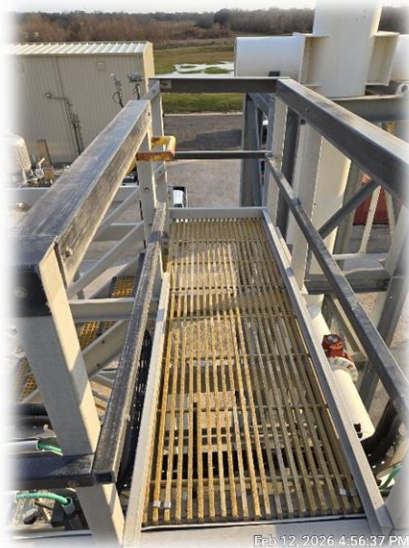
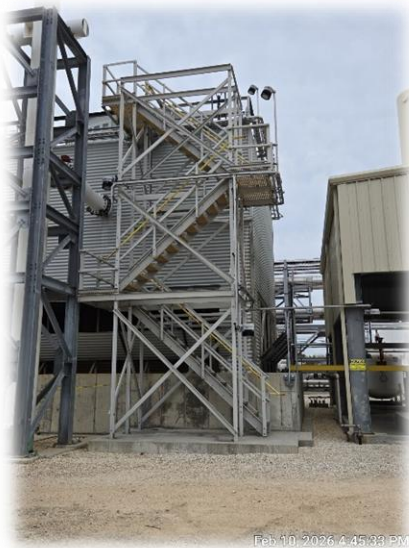
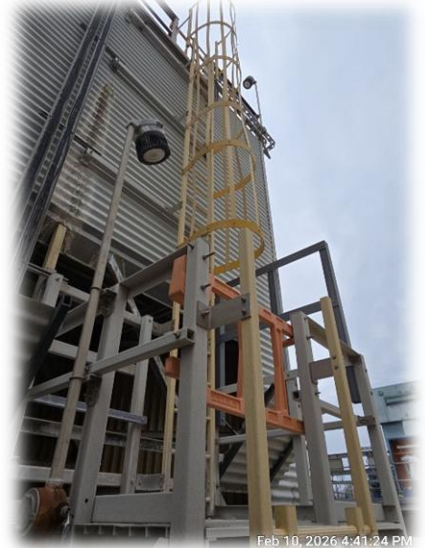
Acceptable

The FRP stair tower providing access to the fan deck is in acceptable condition, as is the FRP escape ladder and associated landing.

The steel stair tower handrails were replaced with new FRP members during the inspection mobilization.

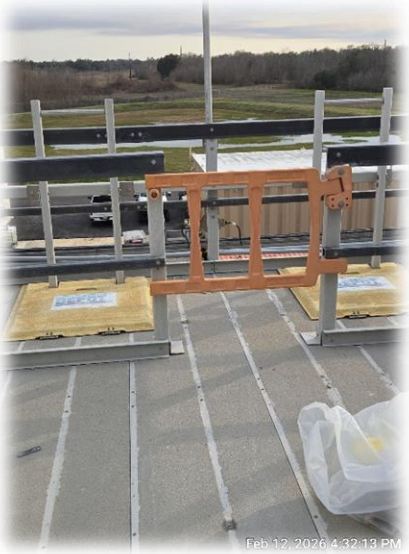
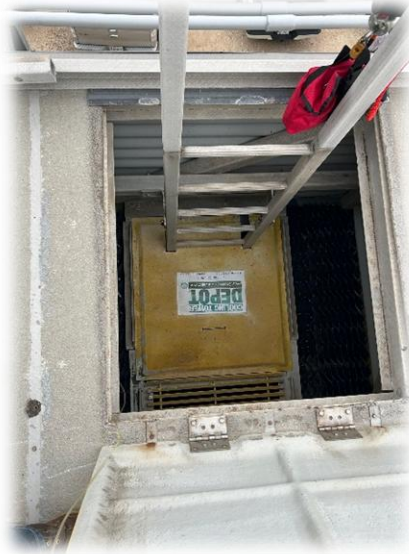
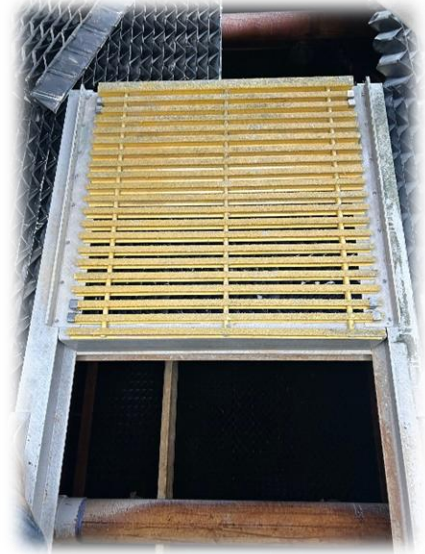
Acceptable

The FRP plenum access doors are in good condition as are the DE access ladders & platforms.

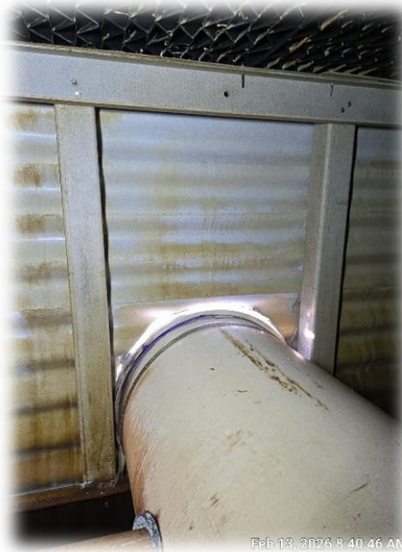
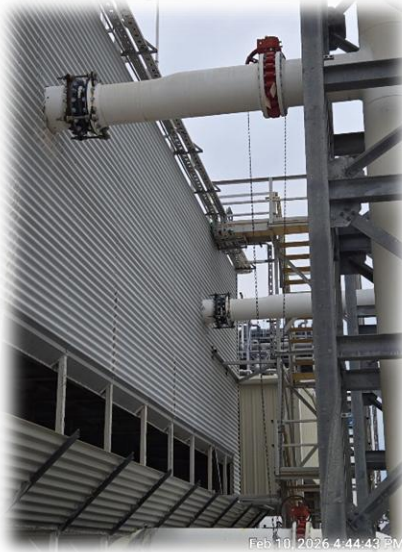
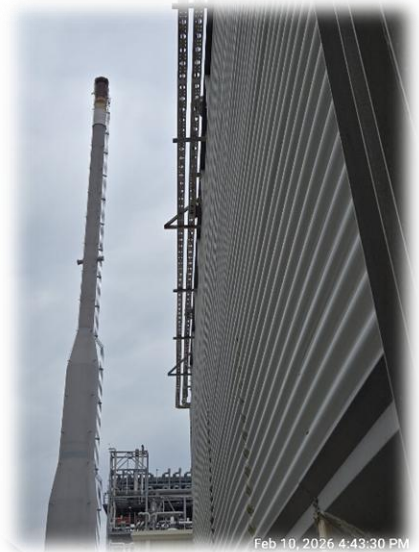
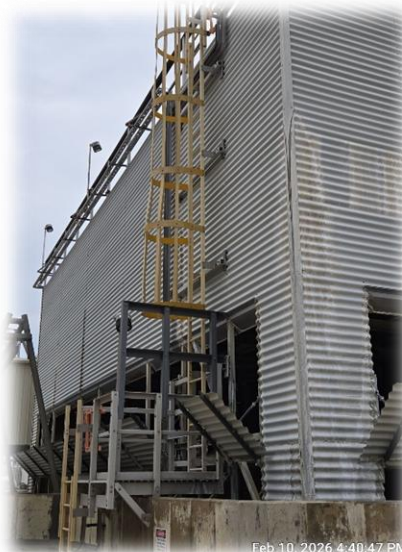
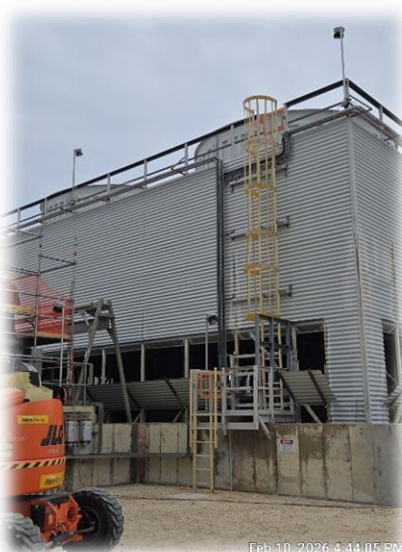
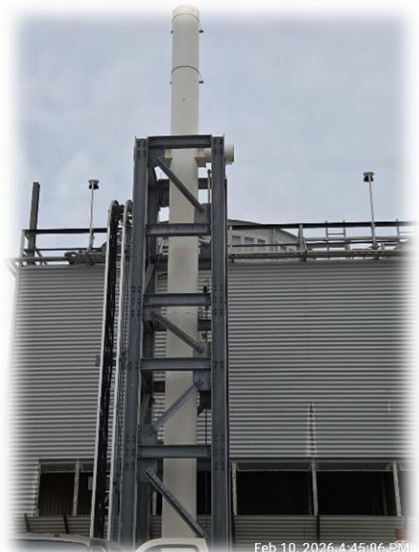
**Low Priority**

The FRP structural wall panels are in good condition with secure hardware, though minor leaks and weathering was noted. Gaps were observed around the headers where they enter the cooling tower allowing air bypass.

- Seal the gaps around the header penetrations to prevent losses in efficiency from air bypass.
- Install new mid-bay supports at the fan deck level to prevent the decking panels from sagging and ensure the decking panels remain properly supported.  
**Note:** In its current condition the fan deck remains safe for use.
- Replace the leaking gearbox pinion seals to maintain proper oil levels and prevent potential damage to the gearing.  
**Note:** The corroded oil lines and gearbox output shafts should be monitored closely for replacement.

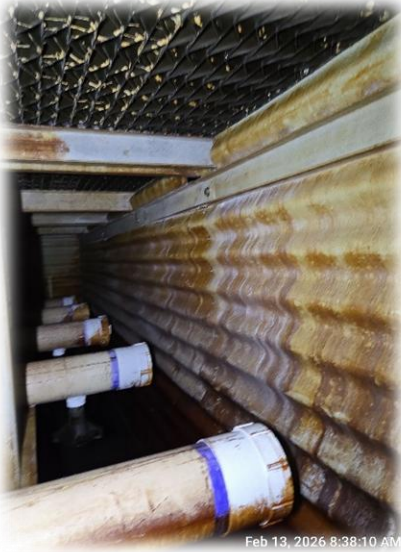
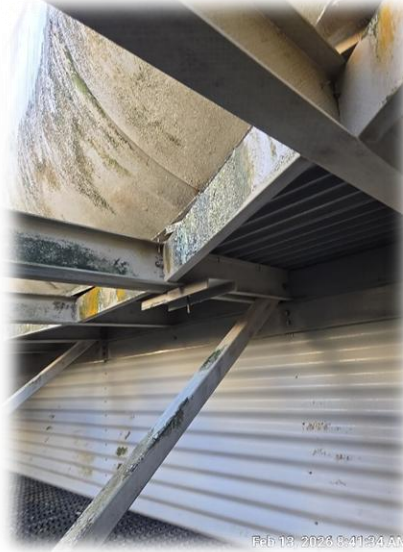
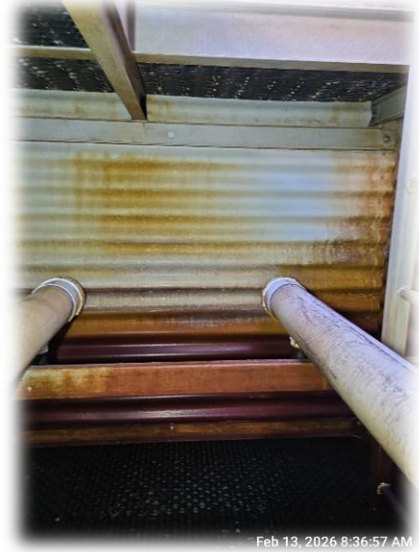
Acceptable

The corrugated FRP partition walls are in acceptable condition.

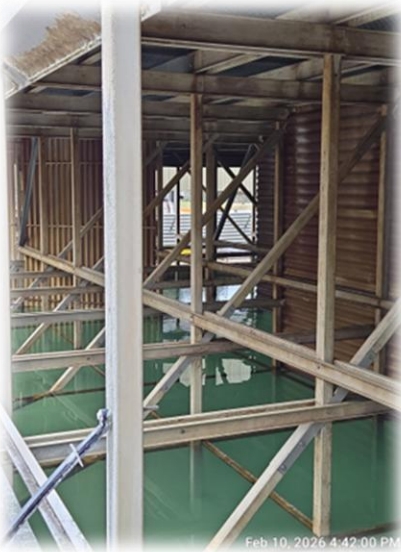
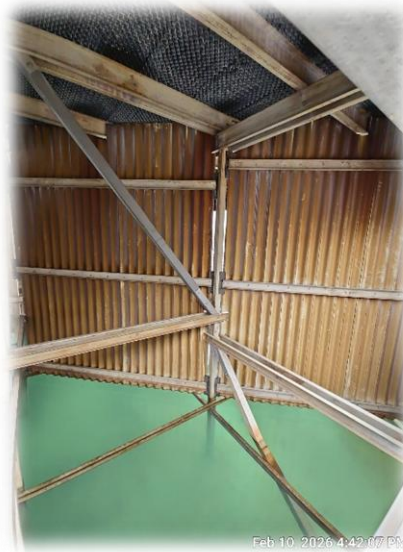
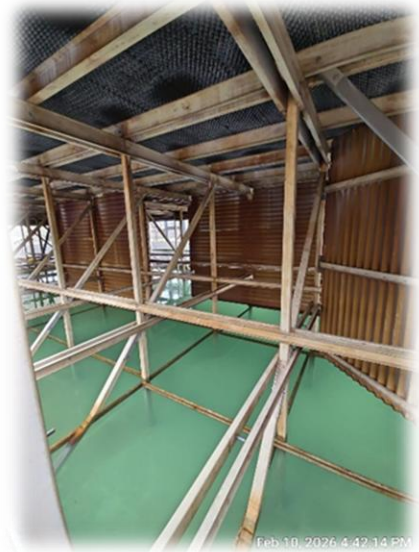
Acceptable

The corrugated FRP wind walls, though dirty, are in otherwise acceptable condition.

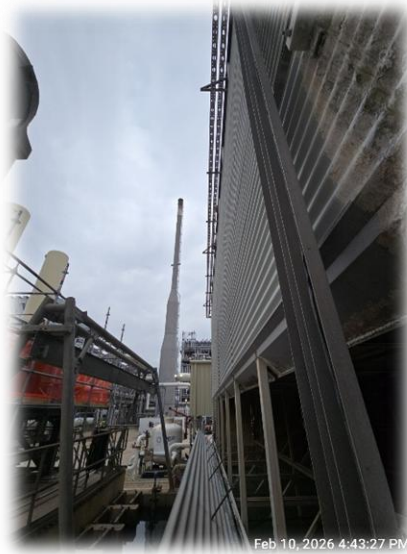
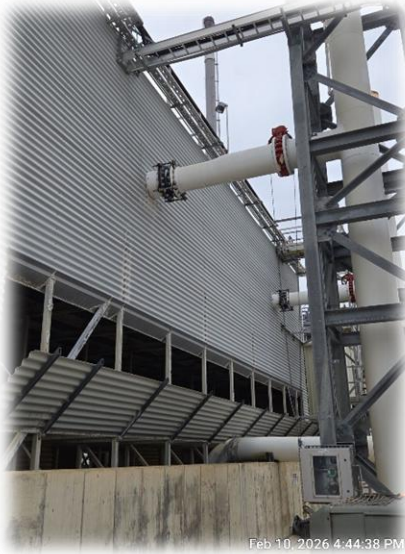
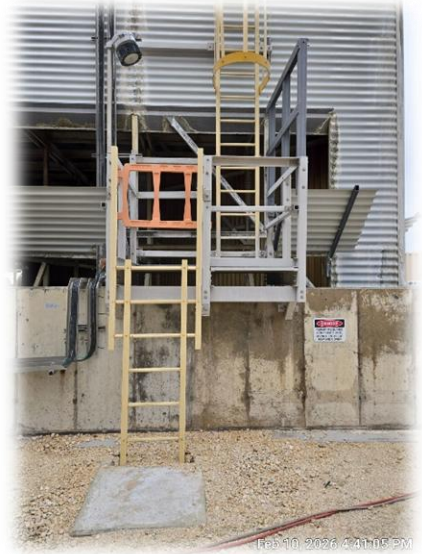
Acceptable

The air inlet louvers are in good condition. No damaged segments were found, however, calcium buildup was observed that should be monitored.

The water diverters are in a similar condition with calcium buildup noted around the perimeter of the tower.

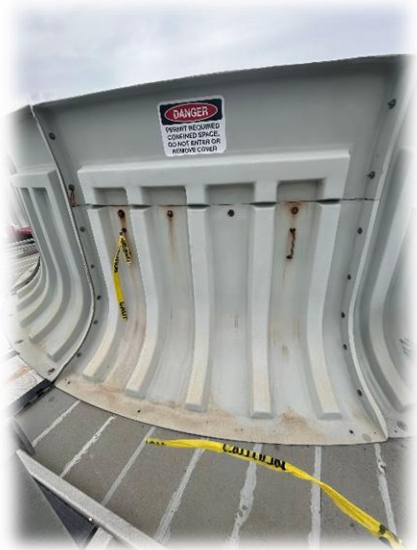
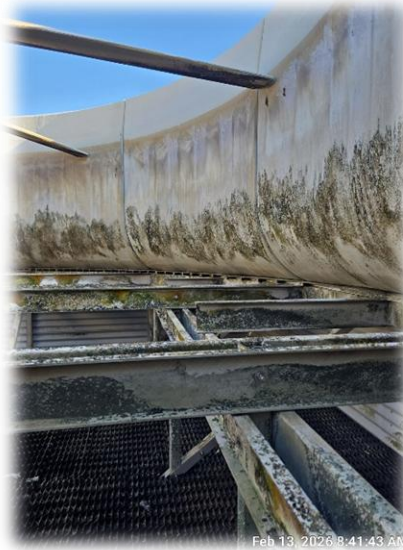
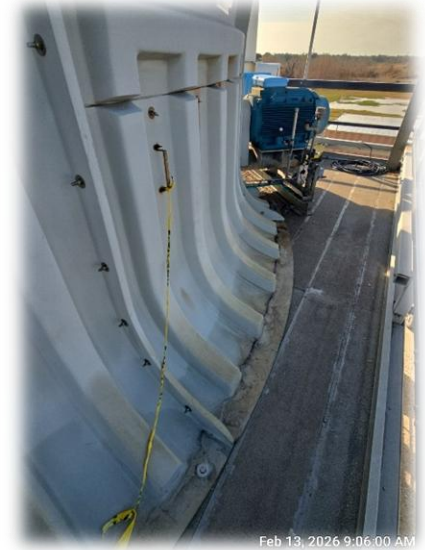
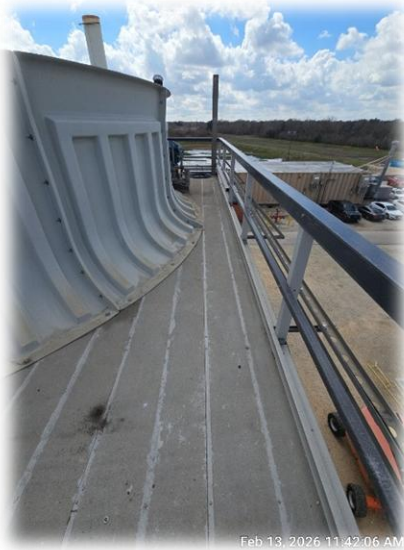
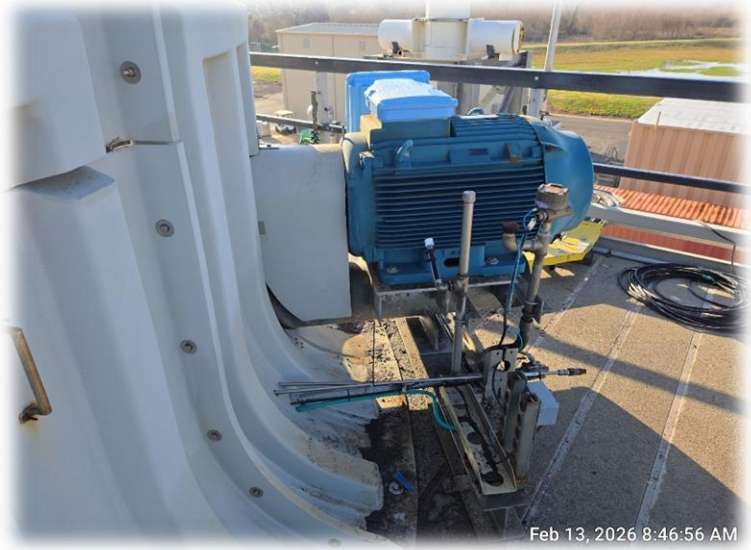
Acceptable

The FRP fan stacks are in good condition. The anchorage and seam hardware are in place and secure.

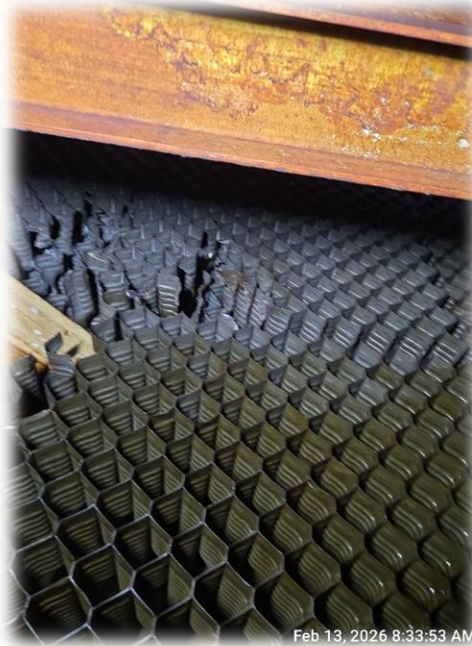
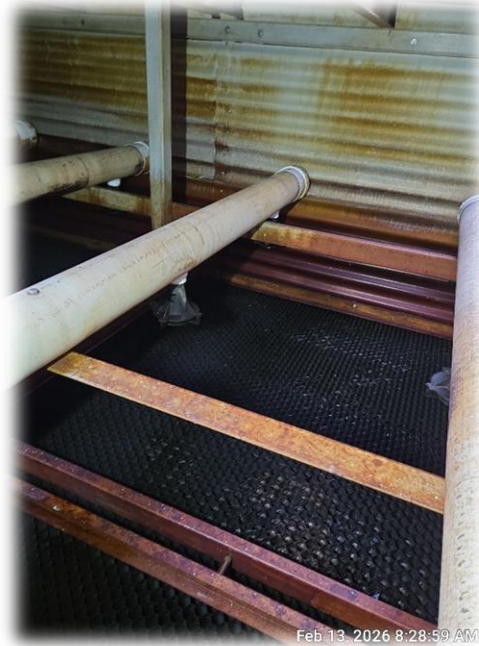
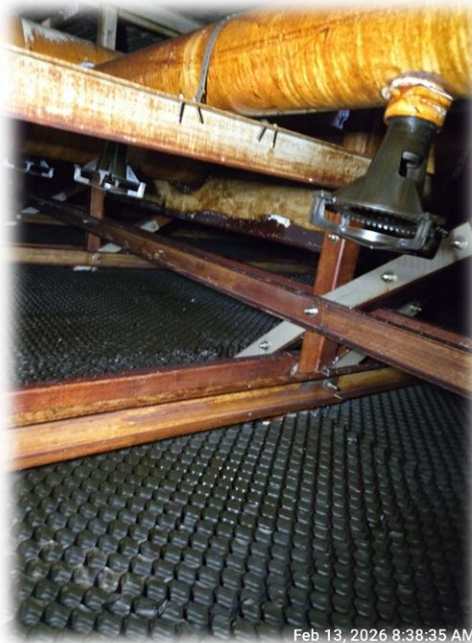
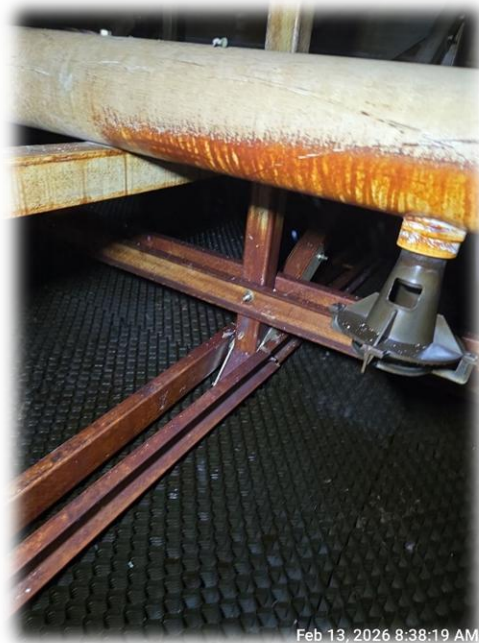
Acceptable

The fill media is in overall good condition. Minor damage was noted on the top layer of fill in several locations that should be monitored during future inspections.

The FRP fill supports are in acceptable condition.

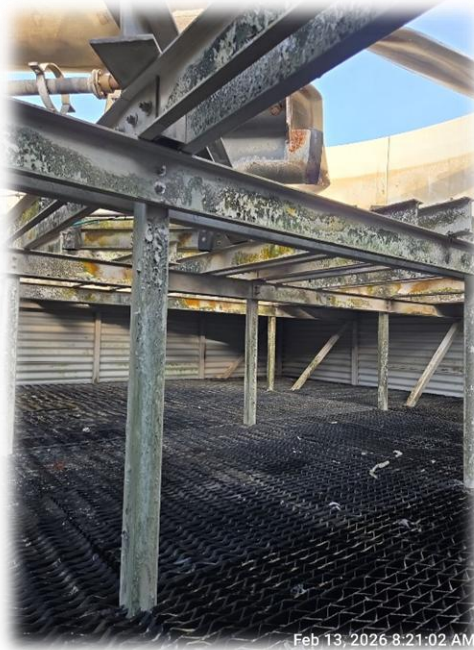
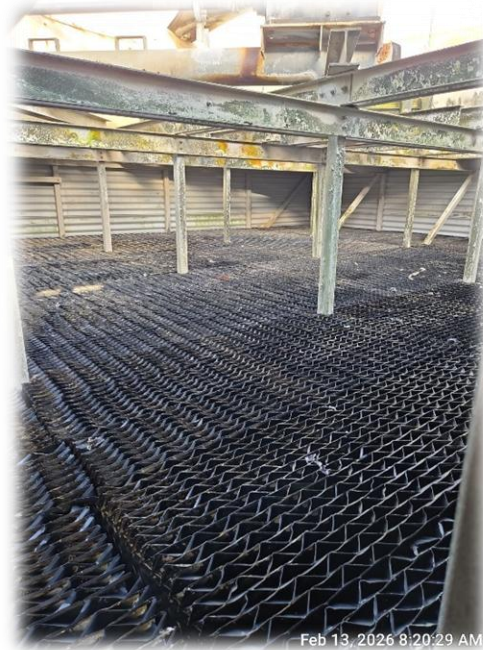
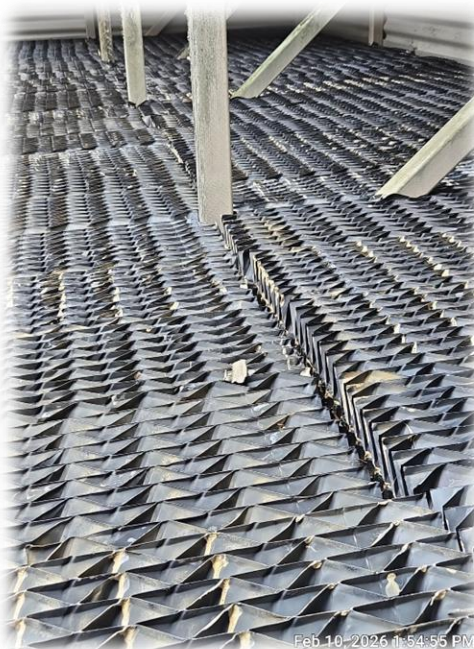
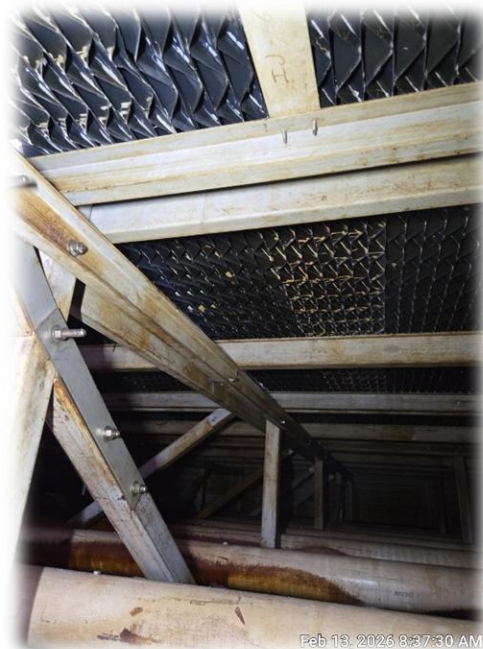
**Acceptable**

Drift eliminators are in good to fair condition. While no damaged or missing packs were noted during the inspection, minor gaps were observed between the packs.

The FRP eliminator supports are in acceptable condition.

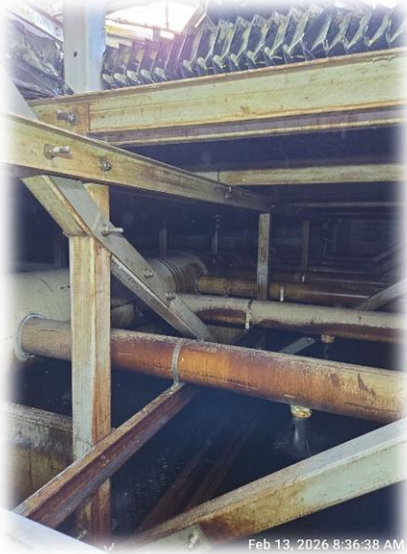
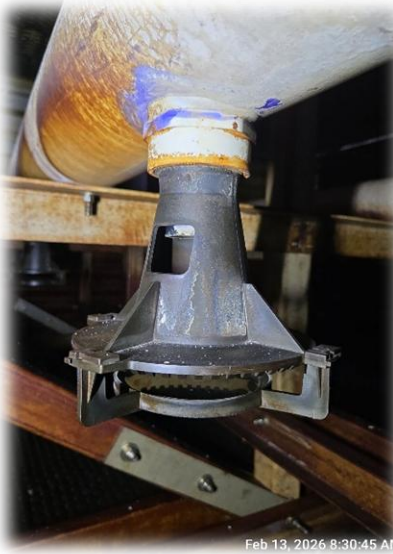
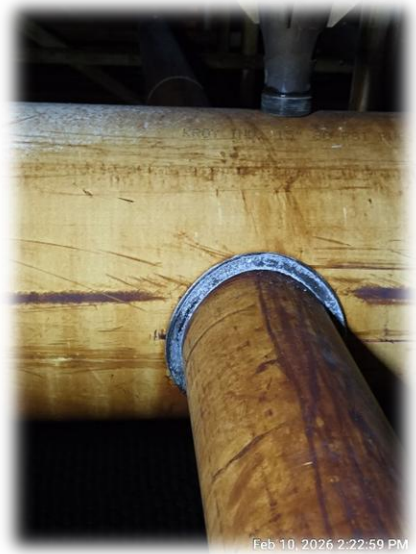
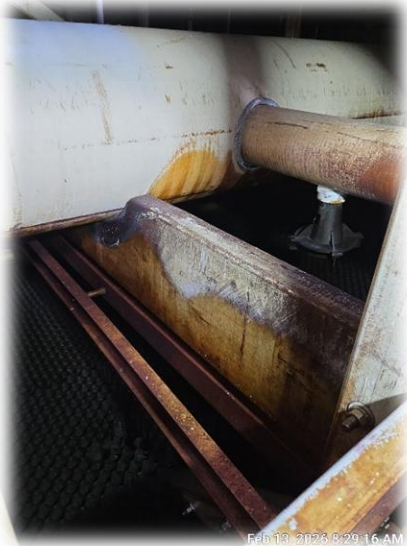
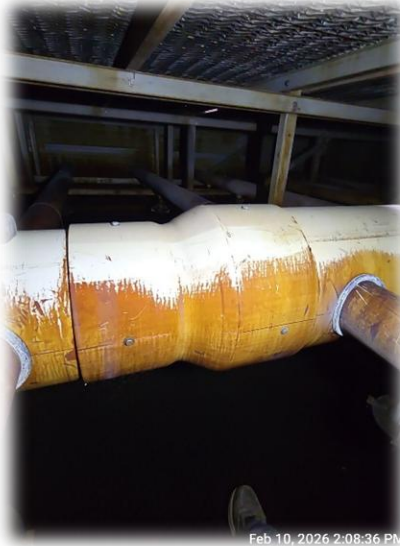
**Acceptable**

The distribution system is in good condition with no loose or missing laterals or nozzles.

The FRP lateral supports and header saddles are in acceptable condition.

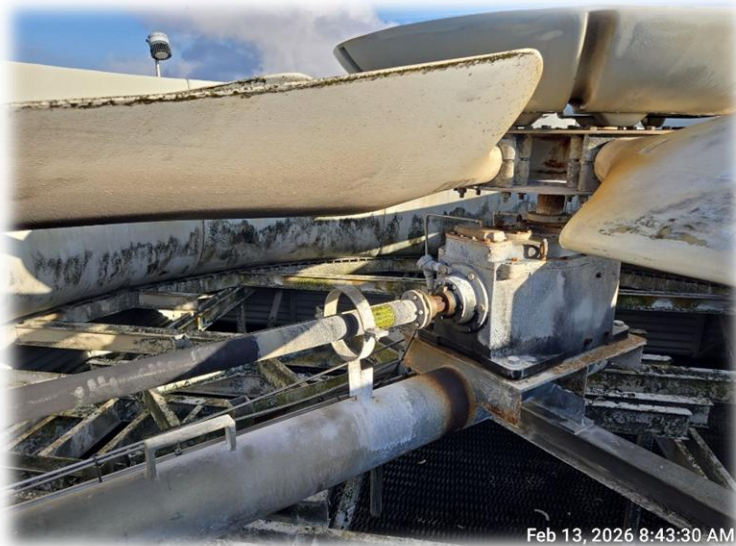
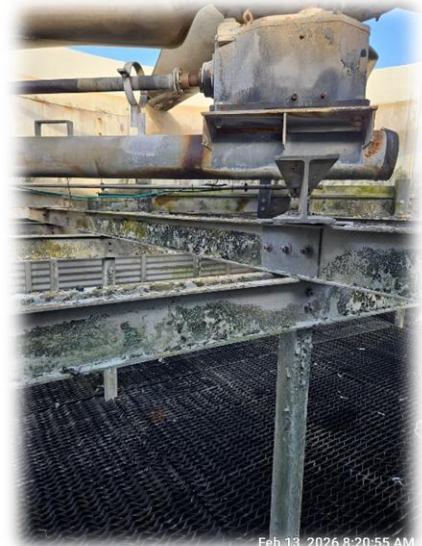
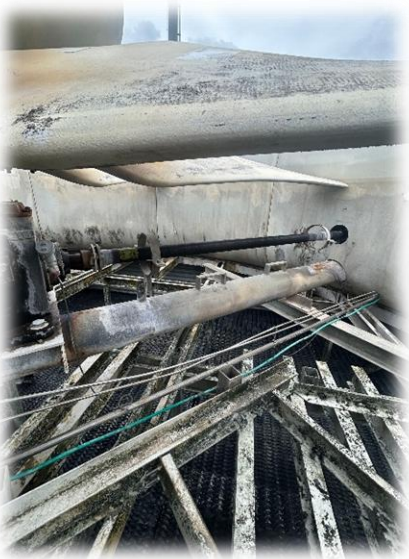
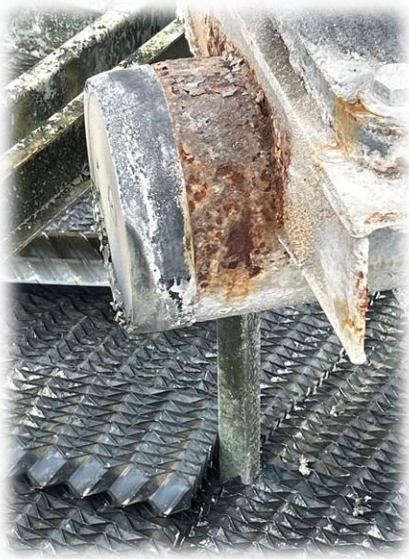
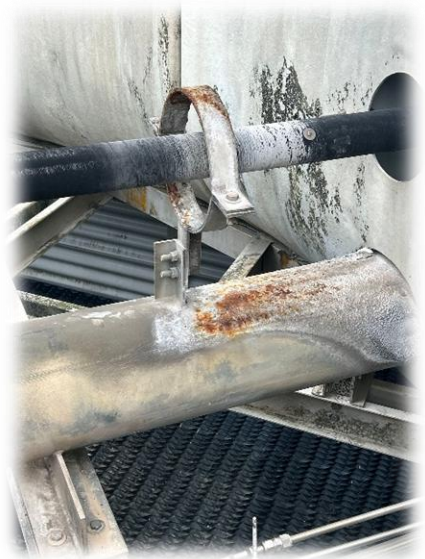
Acceptable

Mechanical support torque tubes are in fair condition with secure hold-down hardware. Corrosion was noted on the gearbox end of the torque tubes that should be monitored during future inspections.

All driveshaft guards were found to be in place and secure.

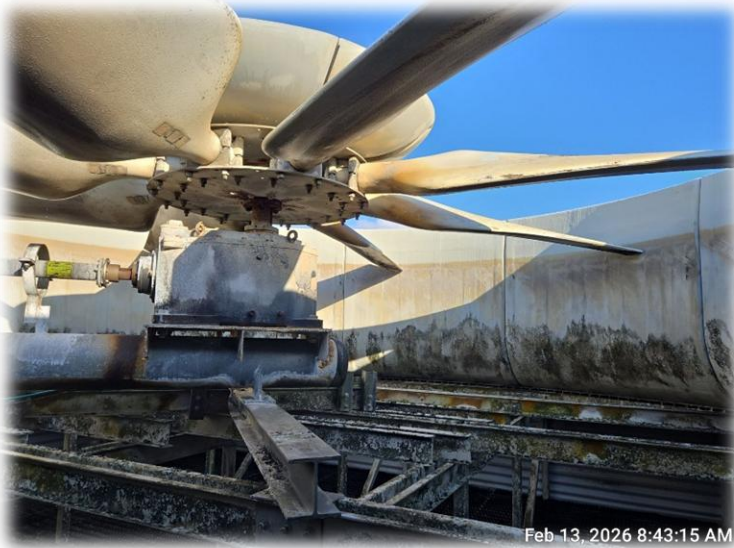
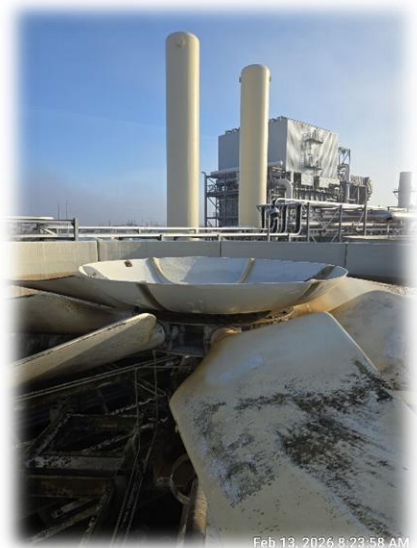
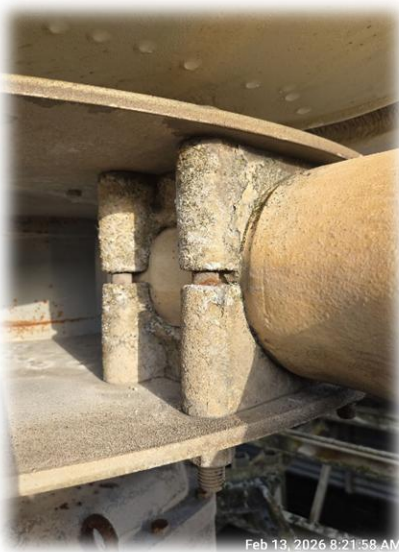
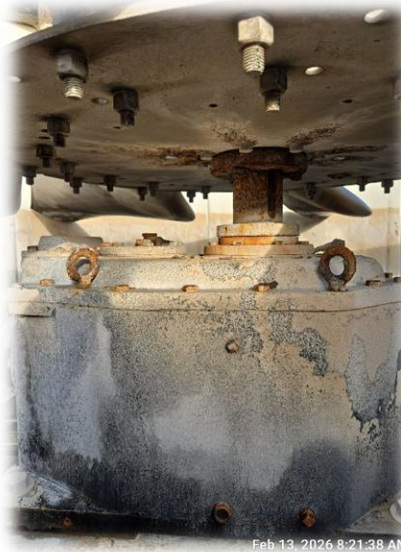
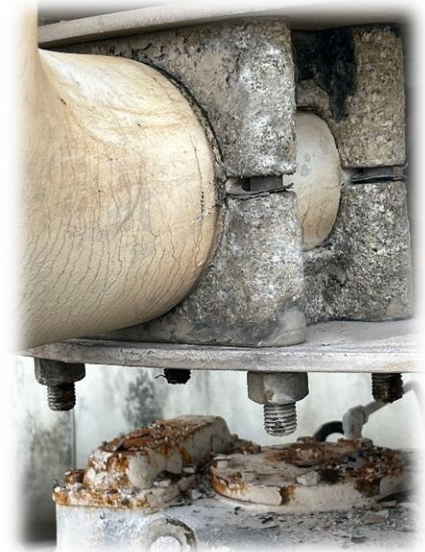
**Acceptable**

The fan assemblies are in good condition with secure blade clamp hardware and unobstructed drain holes. No exposed fibers or blade damage was noted on the FRP fan blades; however the the exterior gel coating is beginning to deteriorate and should be monitored

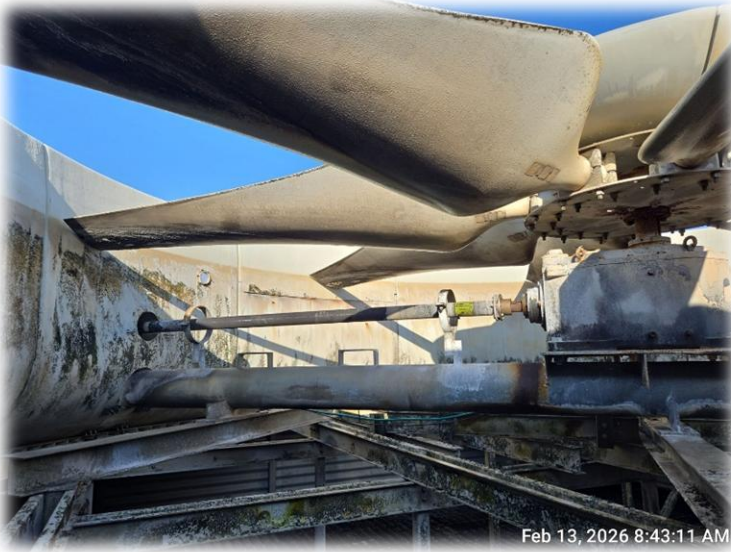
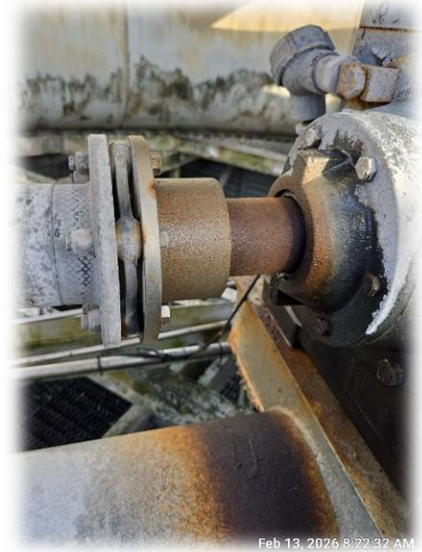
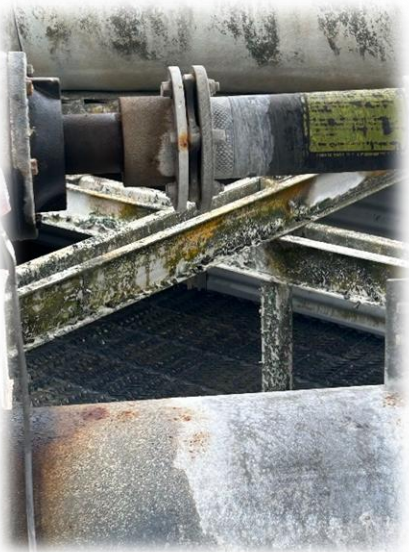
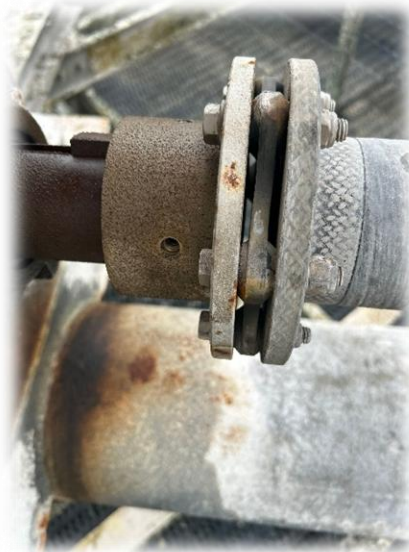
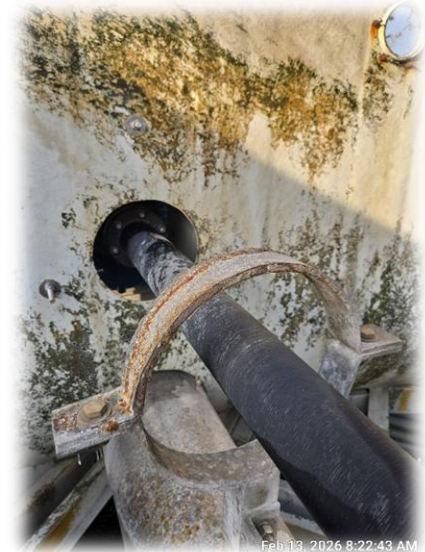
Acceptable

The composite driveshafts are in acceptable condition with secure hardware, as are the associated coupling flex elements.

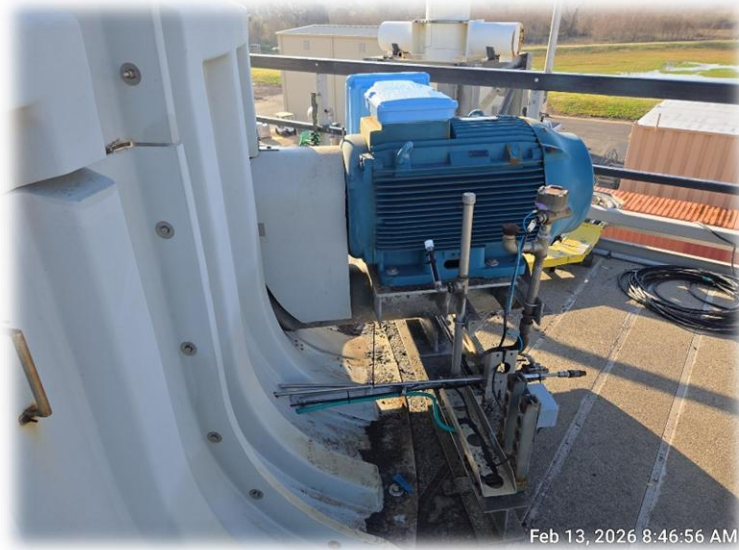
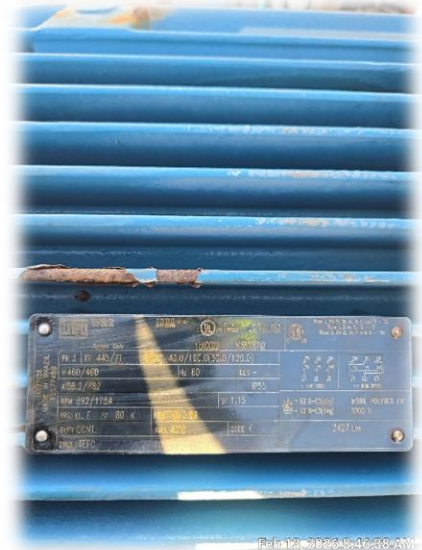
Acceptable

The motors are in acceptable condition with secure hold-down hardware.

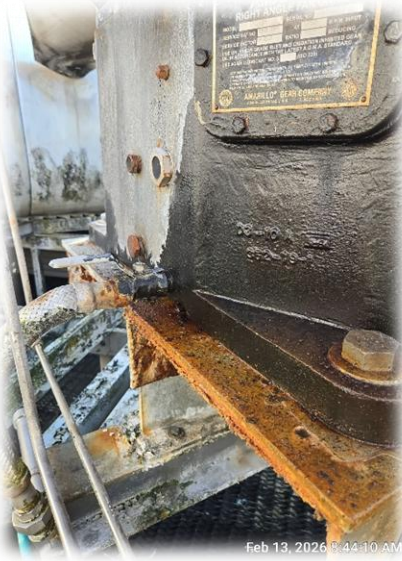
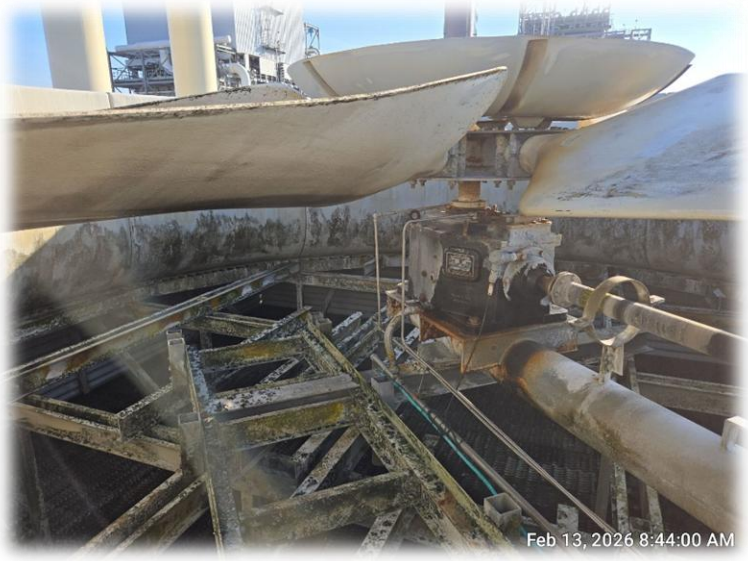
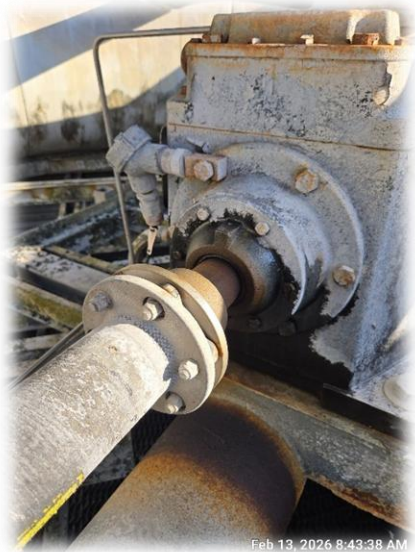
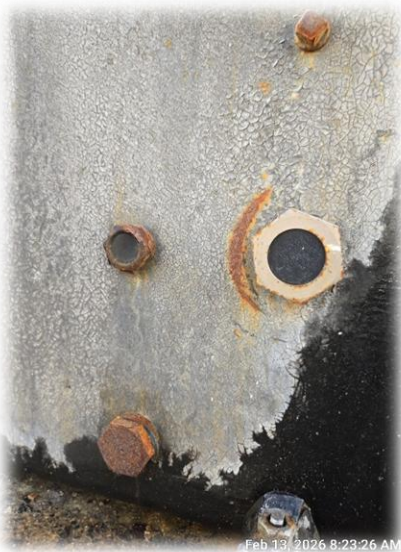
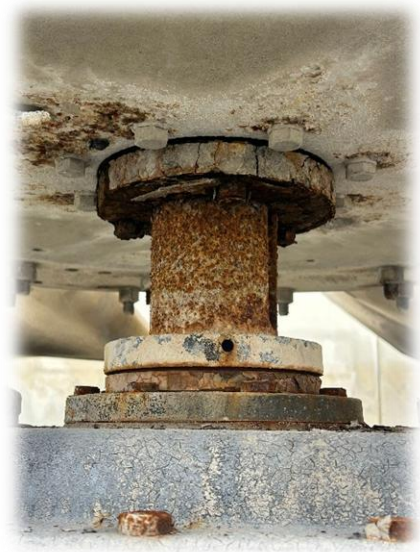
**Low Priority**

The gearboxes are in fair condition with secure hold-down hardware. The gearboxes were noted to have corroded oil lines and output shafts, moderately worn flex hoses, and leaking pinion seals.
