# Urgent Repairs Project Experience List

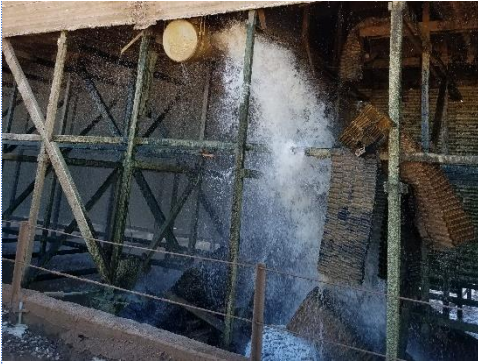
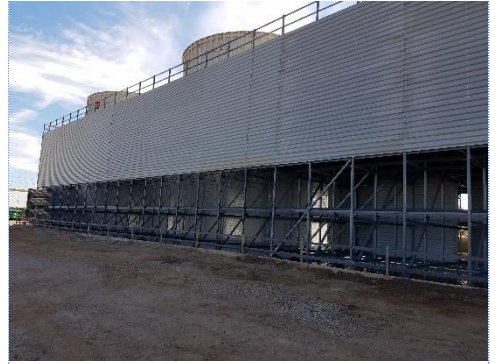
## **Ormat Heber**

### **Header Failure**

During a scheduled structural replacement, the header failed, blowing through the fill and falling into the air inlet. The outage could not be extended.

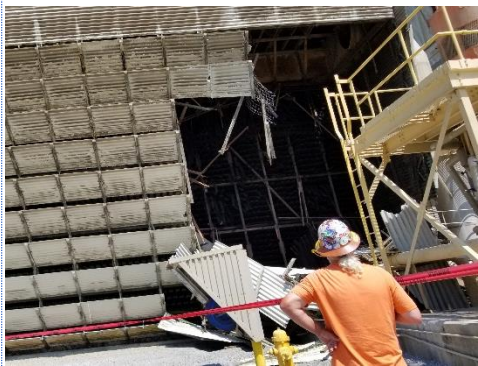
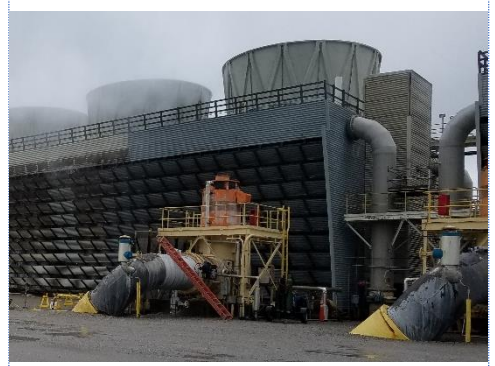
## **EKPC Spurlock Unit 1**

### **Header Failure**

The header collapsed, tearing down a large percentage of the structure and internals in the end cell. This took the tower completely offline and required a nearly complete cell replacement.

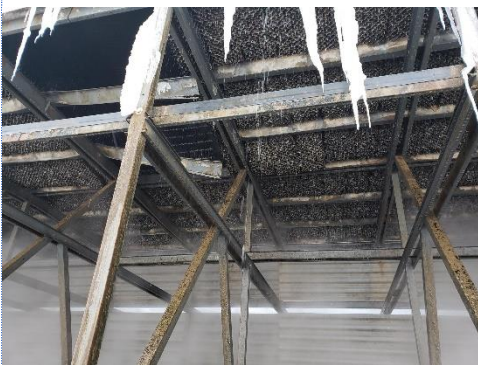
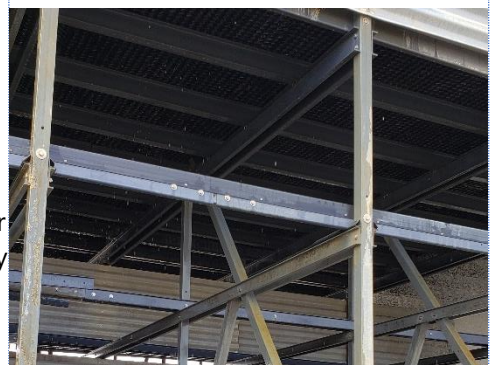
## **Heartland Corn**

### **Fill & Structural Failure**

Due to fill fouling and ice damage, the very heavy fill was falling from the tower and damaging structure. Tower capacity was reduced below acceptable limits and tower failure was imminent.

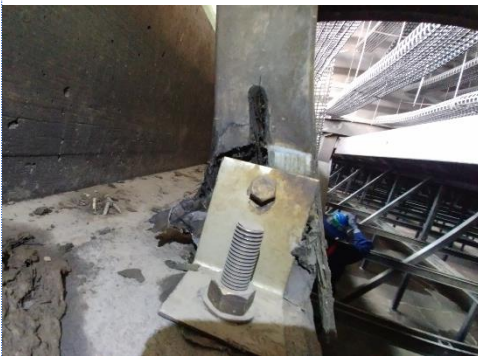
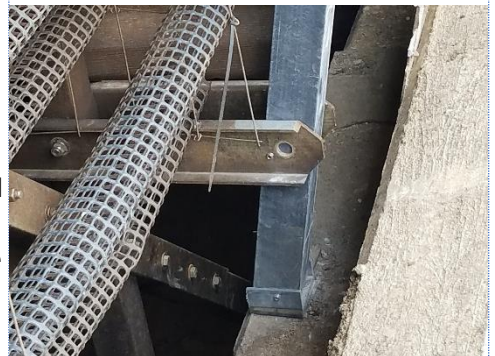
## **OG&E Muskogee**

### **Ice Damage**

Significant ice damage resulted in failed columns, failed louvers, and fallen/deformed fill sticks. Performance wasn't seriously impacted, but the structural integrity was.

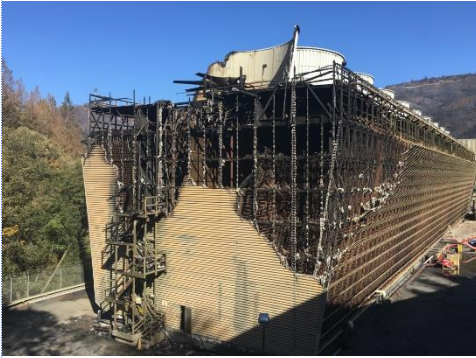
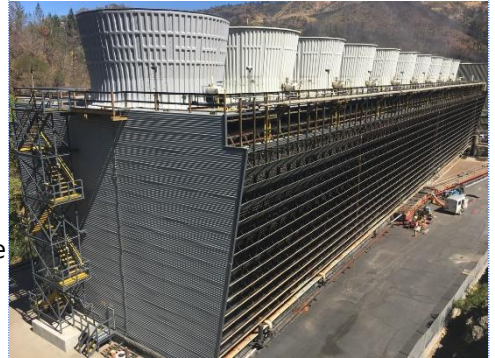
## Calpine Sulphur Spring Unit 14

### Fire Damage

A fire at the end cell of the Class 600 crossflow took the tower out of service. EvapTech mobilized to site, assessed the damage, & performed repairs to bring the tower back into service within one week.

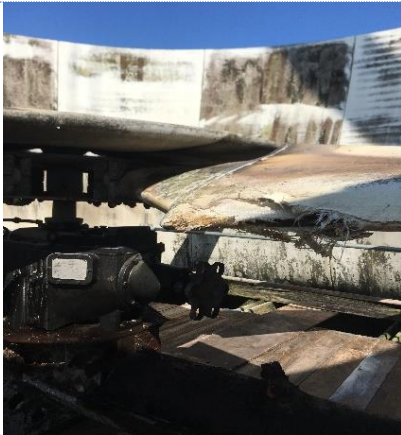
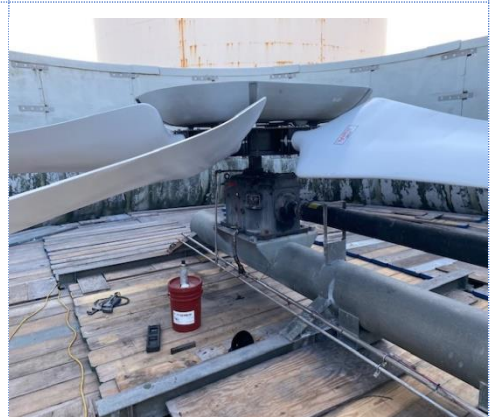
## Linde Plant 849

### Mechanical Failure

When the driveshaft failed, a piece was thrown, damaging the fan blades, fan stack, & mechanical support assembly.

New mechanical equipment was required for expedited fabrication & installation.

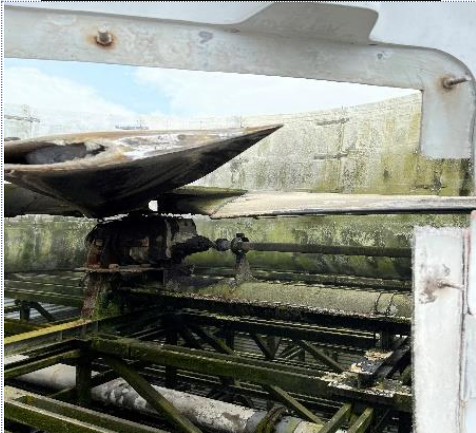
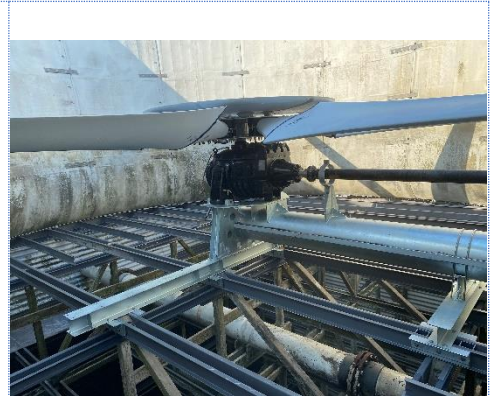
## Linde Plant 742

### Tornado Damage

Tornado damage took the cell offline due to damage to the fan sack, fan blades, fan deck, structure, & mechanical support assembly. Repairs were complete within one week.

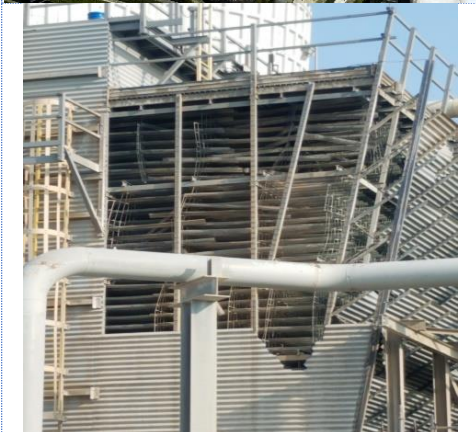
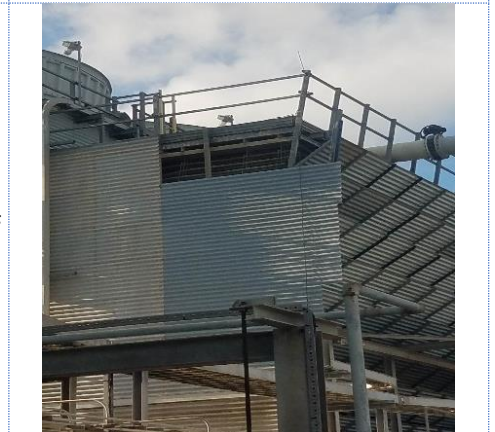
## Cornerstone Melamine

### Hurricane Damage

A hurricane pushed the fan stack out of alignment and damaged end wall casing, louvers, & fill. The repairs were complete within one week of mobilization.

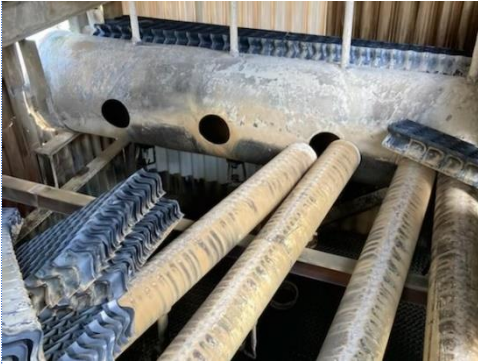
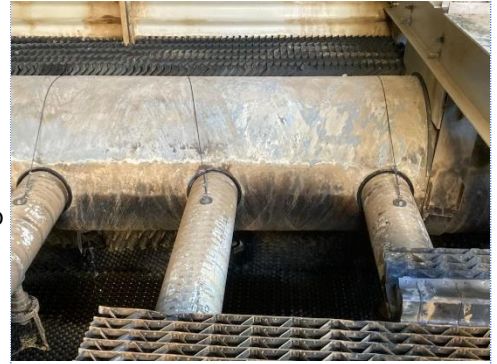
## **Cleco Acadia Power Block 1**

### **Distribution Failure**

The distribution system experienced an upset which blew out the laterals in two of the tower's cells. New laterals, nozzles, & drift eliminators were required for delivery & installation before the cells could be operated.

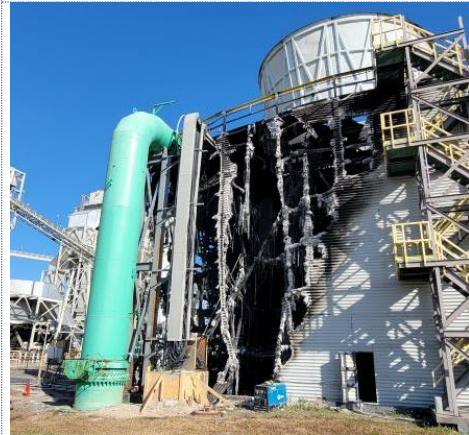
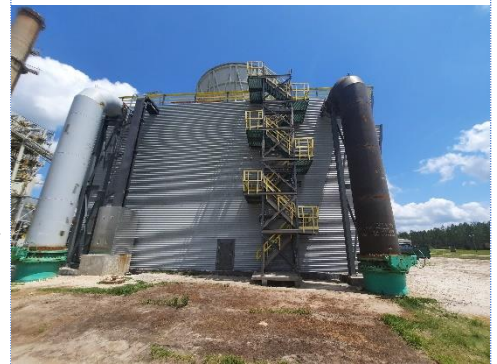
## **Deerhaven Unit 2**

### **Fire Damage**

A fire at the end cell of the Class 600 crossflow took the tower out of service. EvapTech replaced two cells of the cooling tower completely within six weeks.

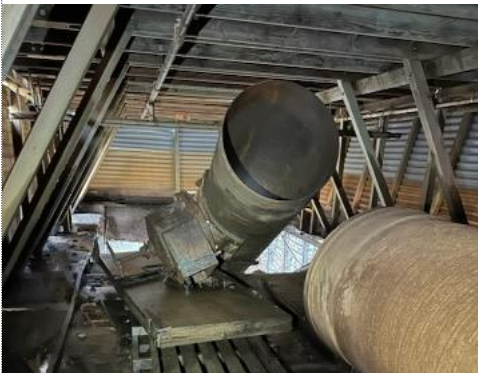
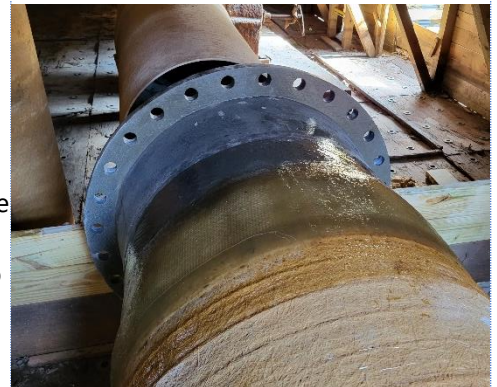
## **Crist Unit 4/5**

### **Header Failure**

The header & structure at the end of the crossflow tower collapsed. EvapTech mobilized to site, capped the header to get the tower back online within two days until the structure was repaired, and then replaced the pipe.
