Urgent Repairs Project Experience List

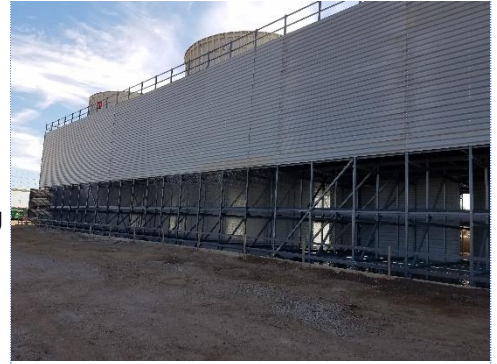
Ormat Heber

Header Failure

During a scheduled structural replacement, the header failed, blowing through the fill and falling into the air inlet. The outage could not be extended.

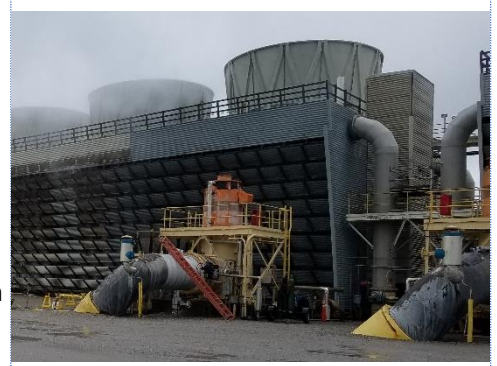
EKPC Spurlock Unit 1

Header Failure

The header collapsed, tearing down a large percentage of the structure and internals in the end cell. This took the tower completely offline and required a nearly complete cell replacement.

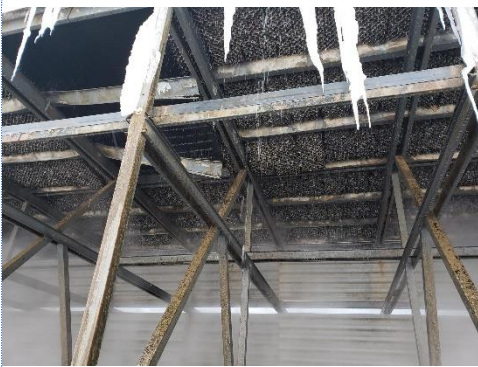
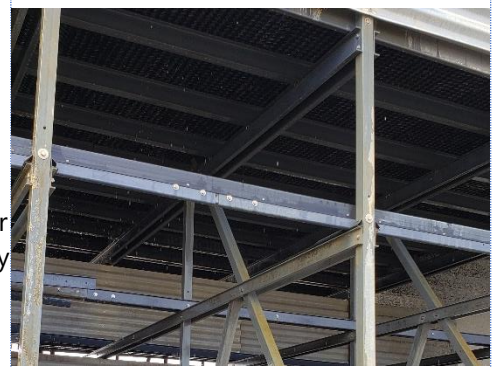
Heartland Corn

Fill & Structural Failure

Due to fill fouling and ice damage, the very heavy fill was falling from the tower and damaging structure. Tower capacity was reduced below acceptable limits and tower failure was imminent.

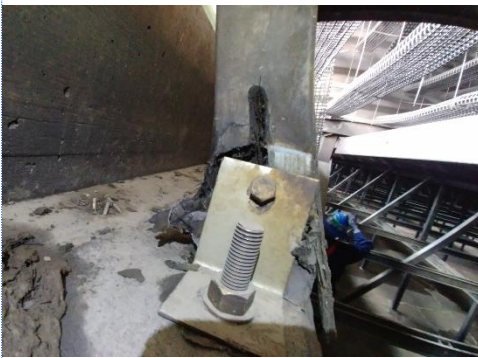
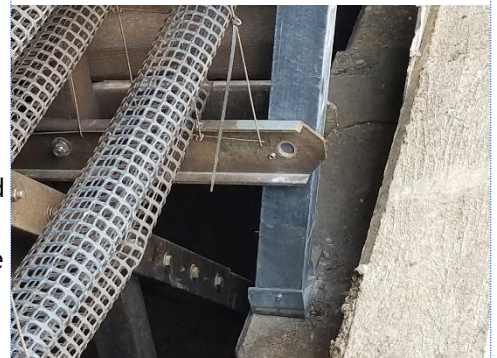
OG&E Muskogee

Ice Damage

Significant ice damage resulted in failed columns, failed louvers, and fallen/deformed fill sticks. Performance wasn't seriously impacted, but the structural integrity was.

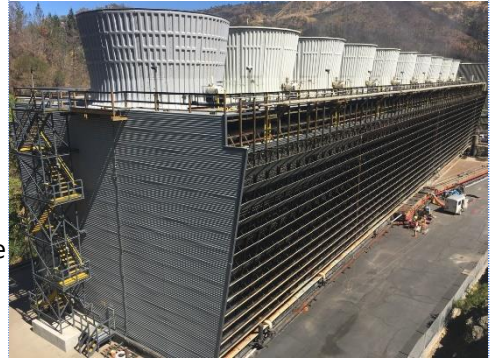
Calpine Sulphur Spring Unit 14

Fire Damage
Middletown, California
November 2019
2-week Lead Time

A fire at the end cell of the Class 600 crossflow took the tower out of service. EvapTech mobilized to site, assessed the damage, & performed repairs to bring the tower back into service within one week.

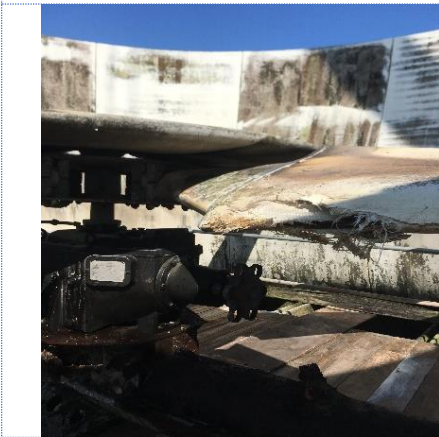
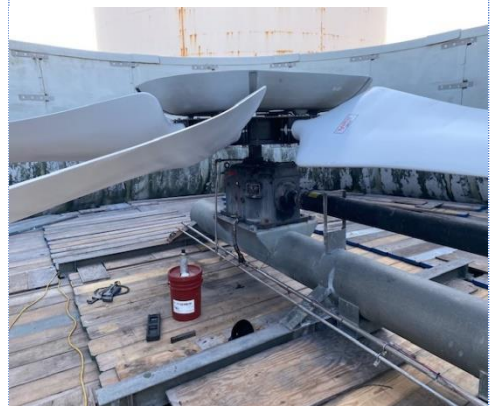
Linde Plant 849

Mechanical Failure

When the driveshaft failed, a piece was thrown, damaging the fan blades, fan stack, & mechanical support assembly. New mechanical equipment was required for expedited fabrication & installation.

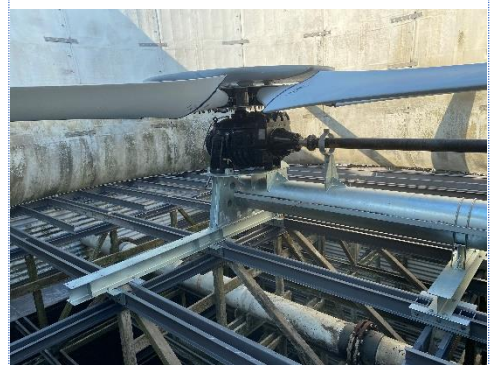
Linde Plant 742

Tornado Damage

Tornado damage took the cell offline due to damage to the fan sack, fan blades, fan deck, structure, & mechanical support assembly. Repairs were complete within one week.

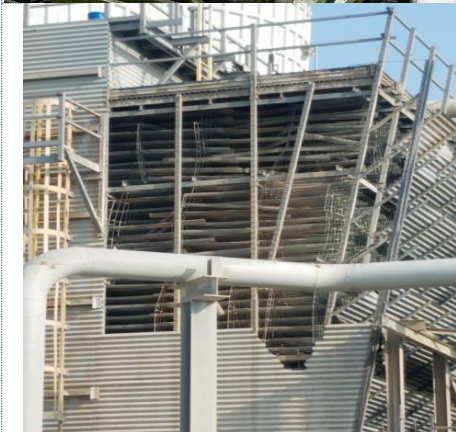
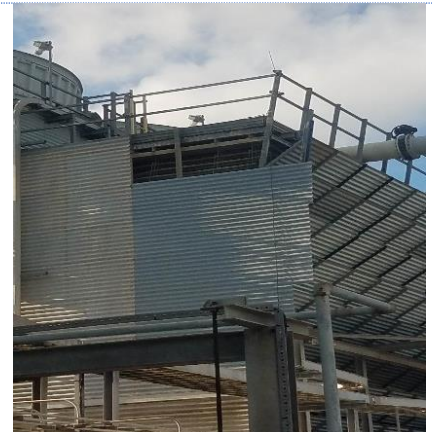
Cornerstone Melamine

Hurricane Damage
Westvaco, Louisiana
August 2021
2-day Lead Time

A hurricane pushed the fan stack out of alignment and damaged end wall casing, louvers, & fill. The repairs were complete within one week of mobilization.

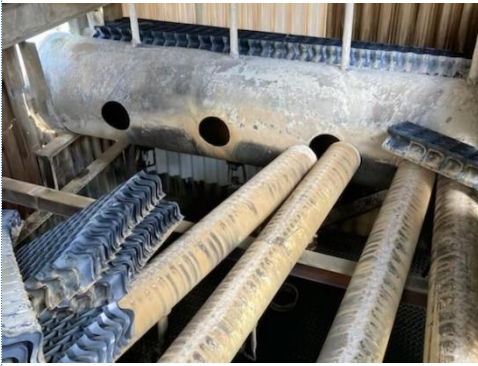
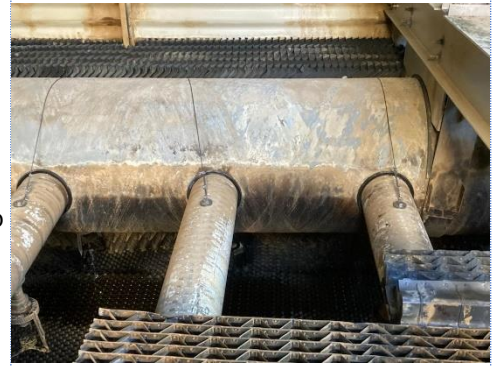
Cleco Acadia Power Block 1

Distribution Failure

The distribution system experienced an upset which blew out the laterals in two of the tower's cells. New laterals, nozzles, & drift eliminators were required for delivery & installation before the cells could be operated.

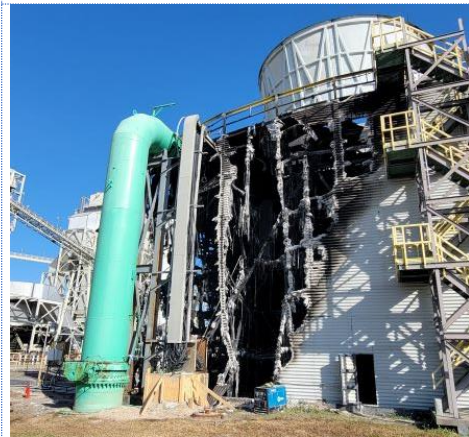
Deerhaven Unit 2

Fire Damage

A fire at the end cell of the Class 600 crossflow took the tower out of service. EvapTech replaced two cells of the cooling tower completely within six weeks.

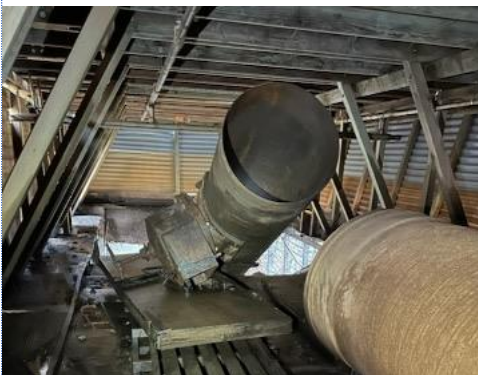
Crist Unit 4/5

Header Failure

The header & structure at the end of the crossflow tower collapsed. EvapTech mobilized to site, capped the header to get the tower back online within two days until the structure was repaired, and then replaced the pipe.
