## Sample Inspection Report

Tower Reference Number: **00000A01**

2-cell FRP-structure counterflow cooling tower, each cell measuring approximately 30' long × 30' wide × 24' tall with a 22' diameter fan.

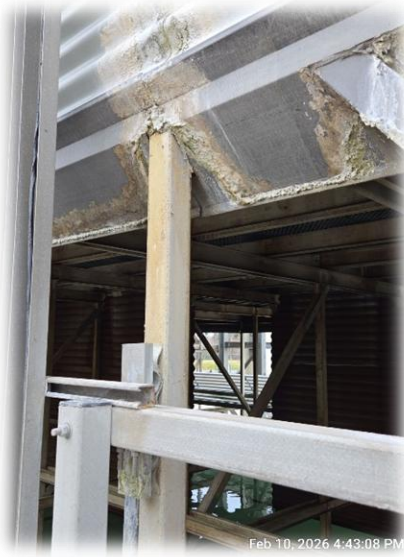
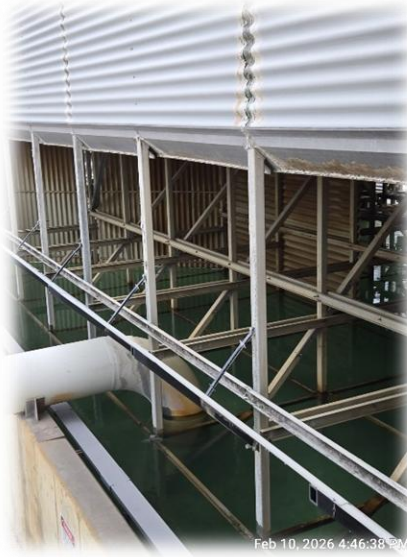
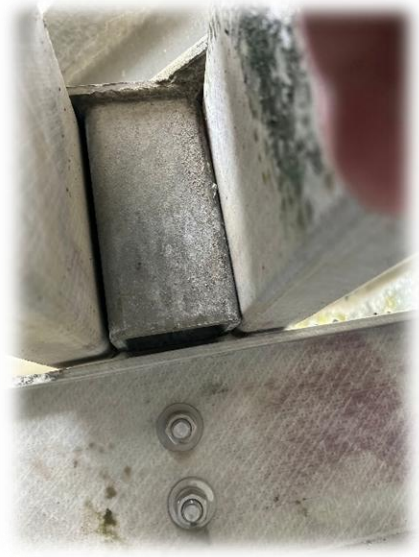
**Tower Structure cont.**

The structure is in fair condition with no loose or missing hardware found during the inspection. Although no damaged members were noted during the inspection, minor weathering was noted throughout the tower that should be monitored during future inspections.

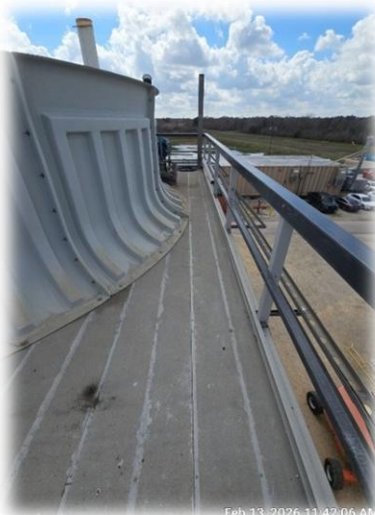
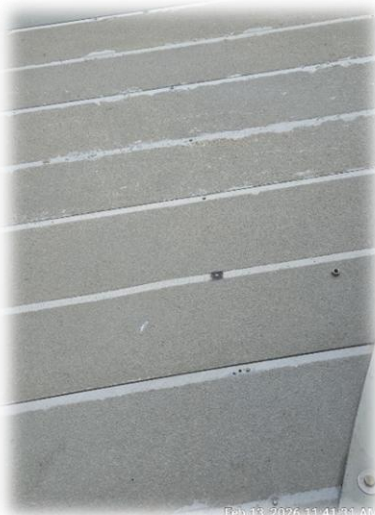
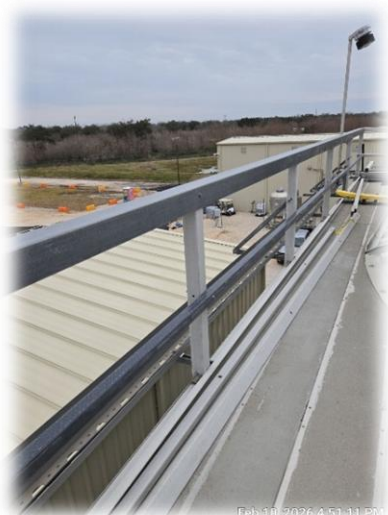
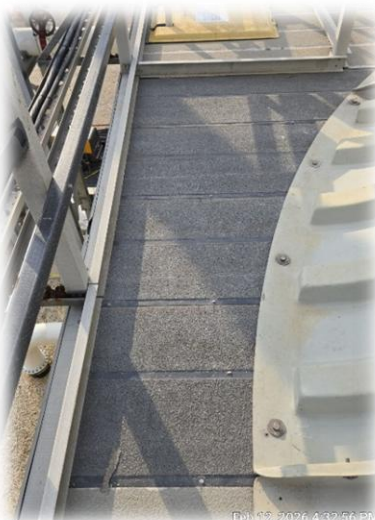
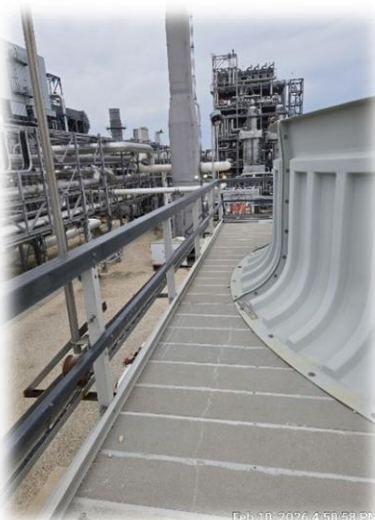
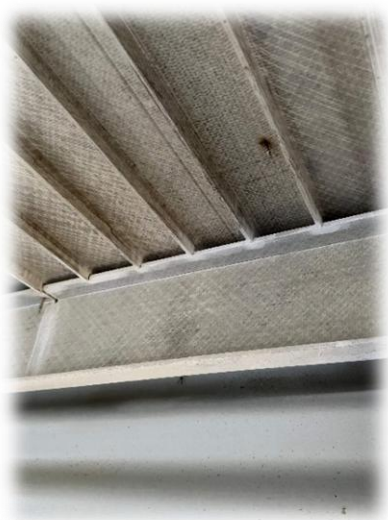
The FRP fan deck is in fair condition with minor weathering and no loose hardware. Decking panels were found to be missing hardware in the center of the panels allowing the panels to bulge and/or sag in some locations. Additionally, a section of fan deck near the cell A stack was noted to be soft and covered with plywood. New fasteners were installed and the soft section of fan deck near cell A was repaired during the inspection mobilization and no further action is required.

The FRP fan deck supports are in overall good condition with the following exception. No mid-bay supports are installed between supports contributing to the sagging deck panels in some locations.

The FRP handrails and knee rails around the deck were noted to be weathered and worn; however, these were replaced during the inspection mobilization and no further action is required.

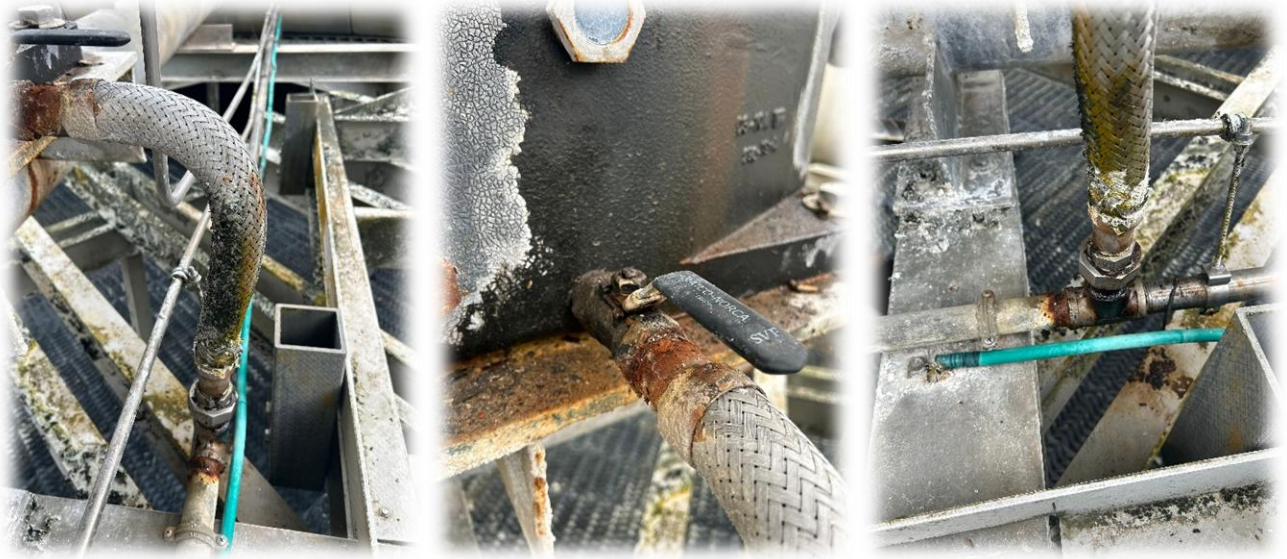
- **Gear cont.**

The gearboxes are in fair condition with secure hold-down hardware. The gearboxes were noted to have corroded oil lines and output shafts, moderately worn flex hoses, and leaking pinion seals.
